REPAIRING VON BACH DAM WALL

Currently at its lowest water level in 20 years, a rare window of opportunity presented itself to repair the Von Bach Dam wall before the first inflow of the 2016/17 rainy season is expected.

By Dr Gert Cloete, Principal Civil Engineer, Knight Piésold Consulting Engineers

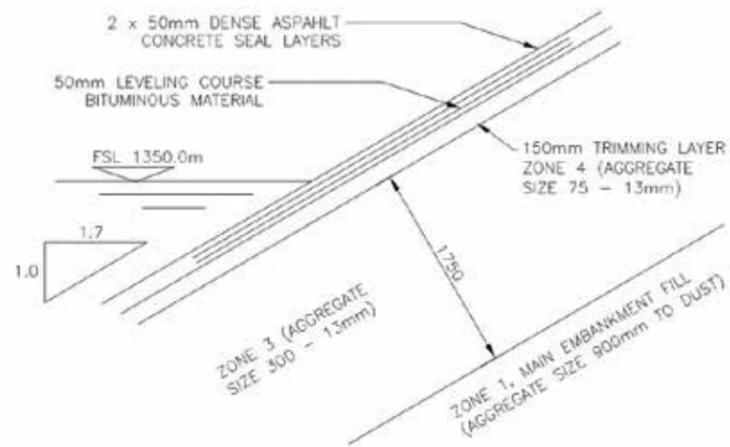
(Above) The Von Bach Dam: cross section of the 1970 as-built asphalt seal

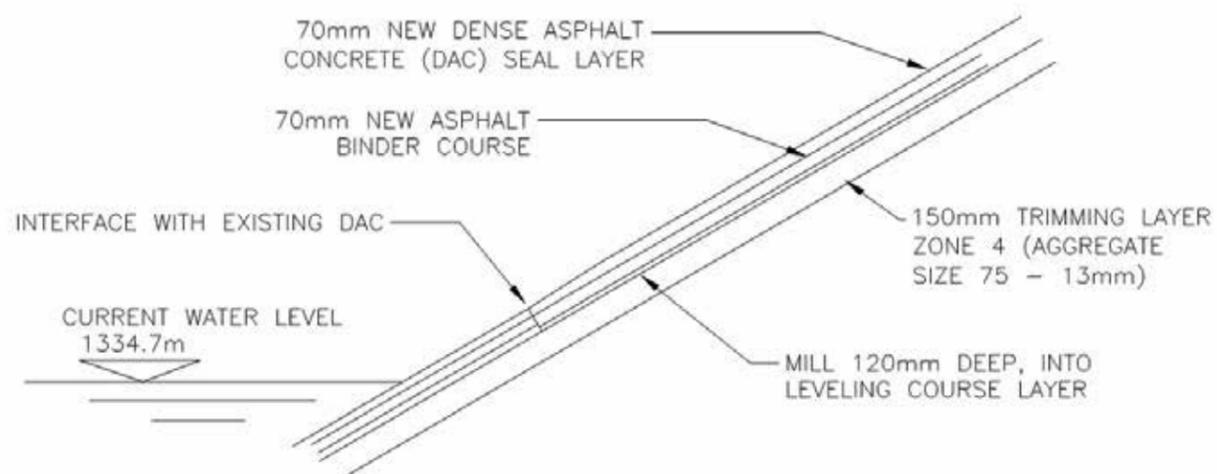
(Above) The Von Bach Dam: cross section of the rehabilitated asphalt seal

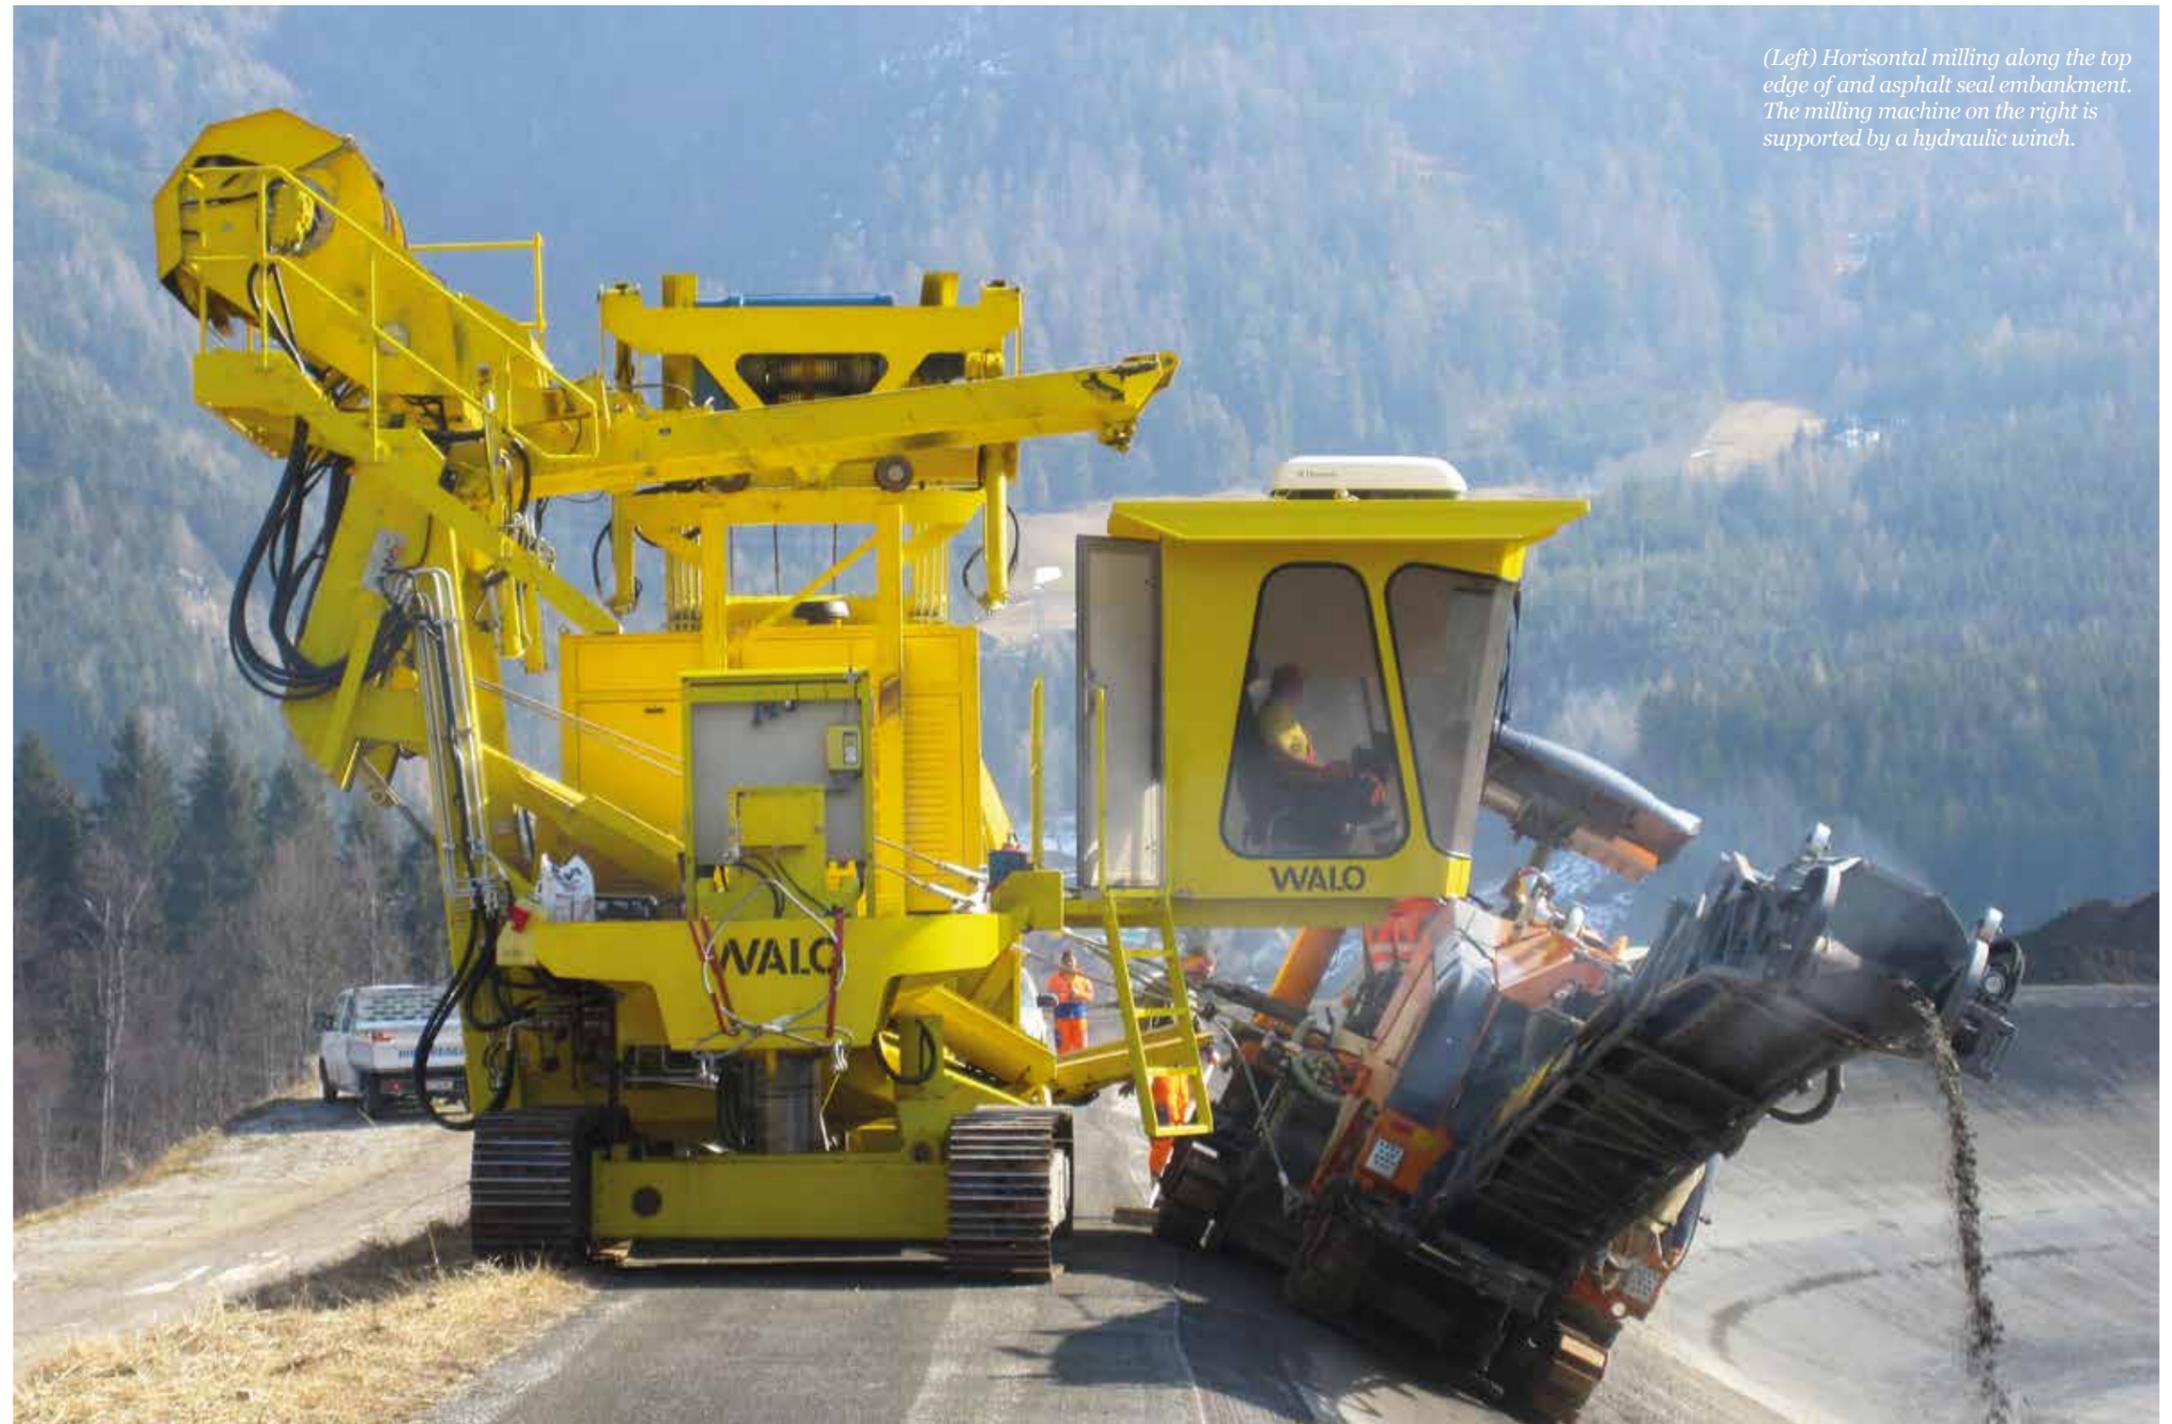
(Left) Horizontal milling along the top edge of and asphalt seal embankment. The milling machine on the right is supported by a hydraulic winch.

Milling equipment was lowered down the surface of the upstream dam wall by hydraulic winch cables so that the old and deteriorating surface material can be milled off. The machinery was drawn vertically up the face of the dam, while the milling operation used a high-speed rotating drum with staggered tungsten bits to grind away at the existing asphalt.

The milled material was then carted off the site. Once milling was completed across the whole 30-m deep horizontal band, the area was prepared for resealing by levelling off irregularities on the embankment surface and applying a tack coat. This whole process took approximately two weeks.
