CHALLENGES IN CLASSIFYING AND DESIGNING SPILLWAY UPGRADES FOR A SMALL EMBANKMENT DAM UPSTREAM OF AN URBAN POPULATION

Katrina T. Wechselberger, P.Eng, Senior Engineer, Knight Piésold Ltd.
Violeta Martin, P.Eng, PhD, Knight Piesold Ltd.
Egbert J. Scherman, P.Eng, Specialist Engineer, Knight Piésold Ltd.
Alana Shewan, P.Eng, Senior Engineer, Knight Piesold Ltd.

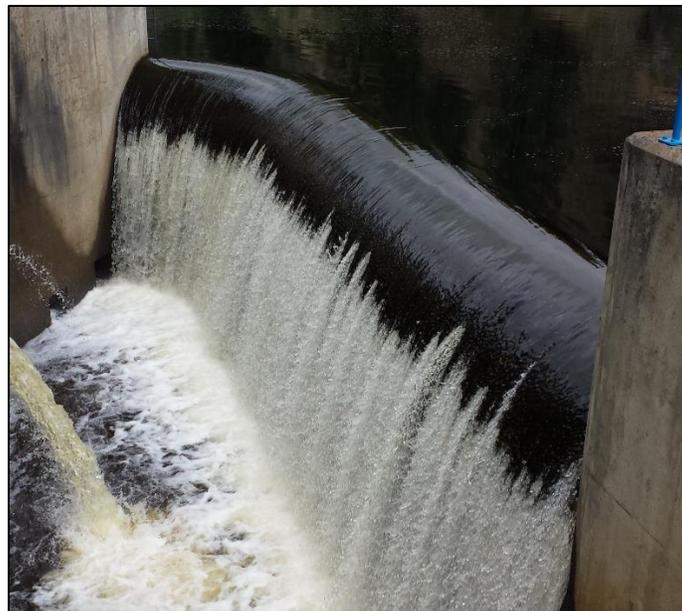
Figure 3: Spillway Overflow Weir

An empirical estimation of the spillway capacity was completed in 2005, suggesting that once the 0.5 m recommended freeboard to the dam crest was considered, the overflow weir had a capacity of approximately $76 \text{ m}^3/\text{s}$. The Inflow Design Flood (IDF) associated with the “High” consequence was $104 \text{ m}^3/\text{s}$. The reservoir is too small to offer any attenuation to the IDF so the spillway discharge capacity was required to pass the full IDF.

It can be seen from the pictures that there is some curvature to the weir at the upstream end which would affect that calculation. In addition, if a small dam crest raise is considered to increase the freeboard and therefore the spillway capacity, it is likely that the upstream end of the spillway would be drowned/backwatered, further affecting the ability to assess the spillway capacity empirically. For this reason a 3D CFD model (ANSYS) of the spillway was used to assess its capacity moving forward, providing confidence in the recommended height of the dam crest raise. The image below shows the spillway when it is drowned/choked at the upstream end during an IDF event.

- A small dam raise in form of a parapet wall would provide the necessary freeboard to safely pass the current IDF without compromising the embankment safety factors.
- It was confirmed that an increase in the Dam’s consequence classification to “Very High” consistent with the high end estimate of Los of Life of 21 persons would result in a larger IDF for which there were no feasible enhancements to the current Dam. The narrow rock canyon limited the spillway capacity upgrade to embankment raises. The larger IDF would result in a raise that would sacrifice the embankment safety factor while coincidentally increasing the potential inundation zone and the PAR in the event of a breach.
- The low end estimate in Los of Life (3 persons), on the other hand, confirms the Dam’s classification as “High”, and the Dam could be brought into compliance in relatively short order.
