# **SELATI TAILINGS DAM DECANT FAILURE AND REMEDIAL ACTIONS**

AJ Strauss<sup>1</sup>

1. Knight Piésold Consulting, South Africa

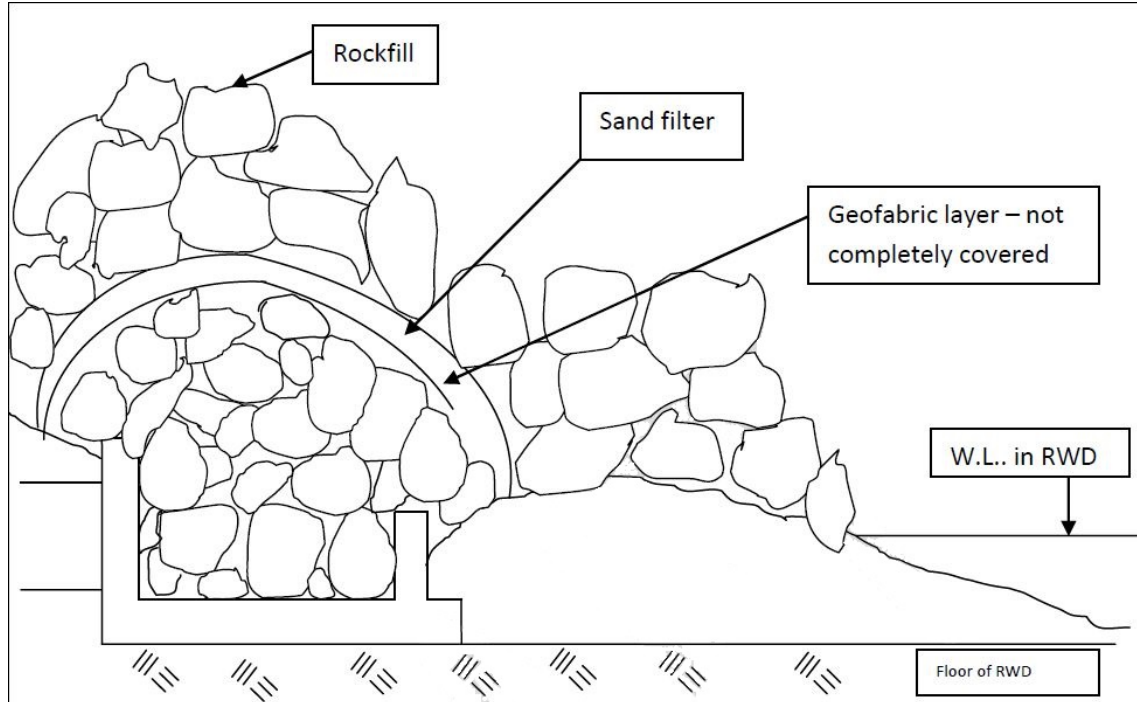
**Figure 6 Constructed filter schematic**

Firstly, a layer of geofabric was placed over the rock fill, almost covering the full exposed surface. A layer of fine filter material was then placed over the geofabric and spread evenly. The available quantity of geofabric was insufficient to cover the full rock fill area. Flow was exiting the rock fill in the area where the slippage occurred during the night of 28<sup>th</sup> February. This is the area not covered completely.

As part of managing the water flow, this area was left undisturbed, while rock fill was again placed onto the filter material layer. The constructed filter is presented graphically in Figure 6.
