Managing Excessive Pit Wall Deformation of Weak Rock Mass

Salina Yong *Knight Piésold Ltd., Vancouver, Canada*

Justine Ealy, Christina Foster *KGHM, Ruth, USA*

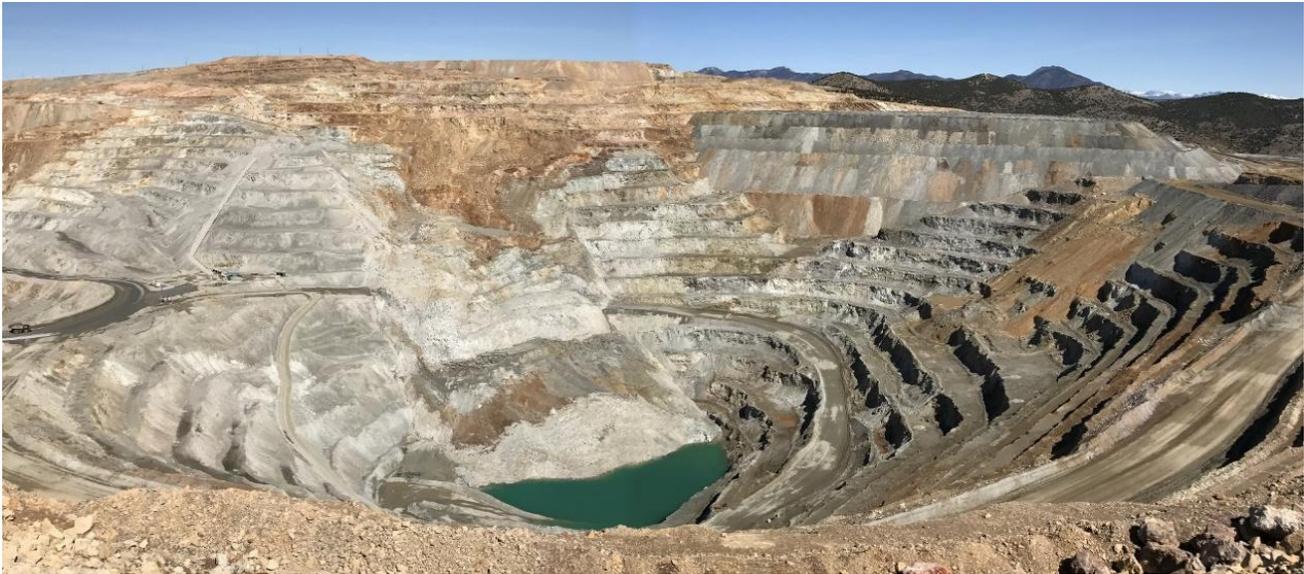
Figure 1. Failure of the north wall (picture taken in early 2017).

Following the stoppage of mining, the slide debris of the north wall instability continued to creep towards the bottom of the pit (Figure 1). This movement displaced the haul road approximately 300 feet towards the pit bottom and locally increased the height of the back scarp to approximately 150 feet. Radar monitoring indicated the creep was stabilizing at a rate of four to five inches per day. The mine requested assistance with the design and planning of the rehabilitation to dewater the pit and to resume mining in 2018.

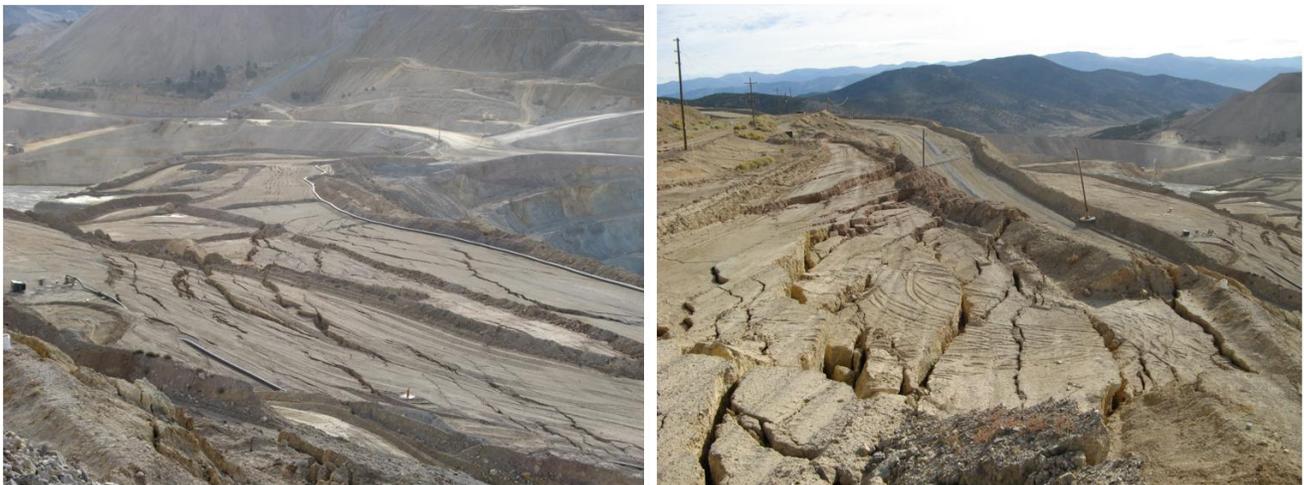
Over the next year, a third intersecting fault was exposed to bound the bottom of the displacing wedge of rock mass in the north wall. Mining at the toe of the north wall and elevated pore pressures from heavy rainfall and snowmelt again accelerated slope movement and the development of tension cracks (Figure 2). A terrestrial radar

Figure 2. Tension cracks above the north wall.

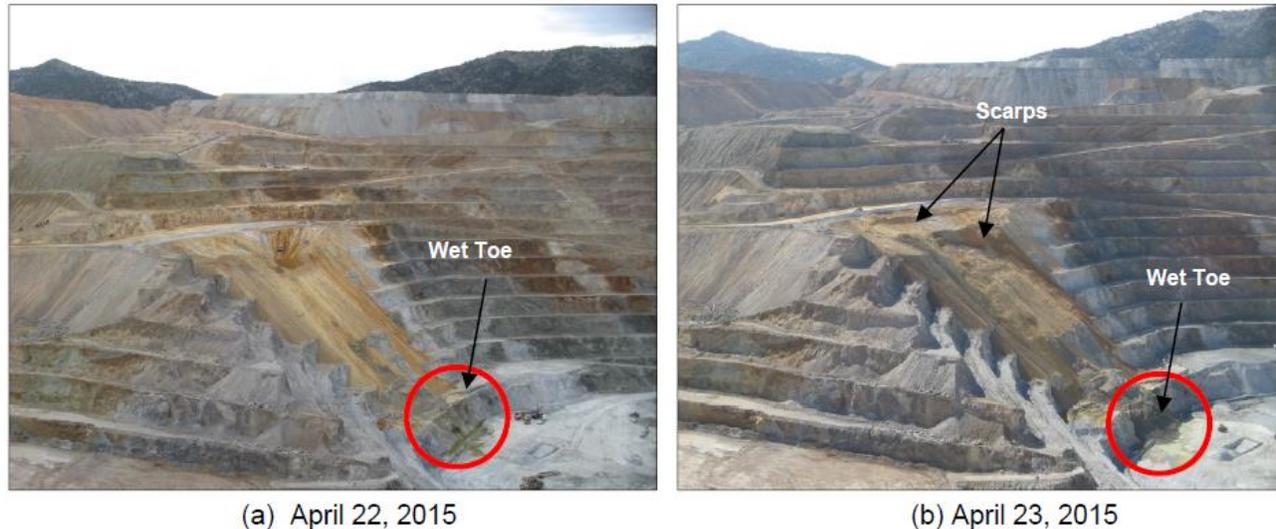
In addition to the north wall, the east and south walls also experienced instabilities in the early phase of mining. Artesian conditions were encountered when a fault was exposed early (2013) in the development of the east wall. Slope movement and tension cracks developed as a result. A later (2015) failure involved two episodes that measured approximately 350 feet high and 400 feet wide (Figure 3). This instability was attributed to the exposure of a localized weak zone near the base of the pit wall and coincided with the observations of seepage and surface ponding. The nearby fault (first exposed in 2013) was likely providing the source of water as it is a known hydraulic conduit in the area. The instabilities were mitigated by incorporating step-outs, dewatering, and installing horizontal drains.

Figure 3. Failure of the east wall.

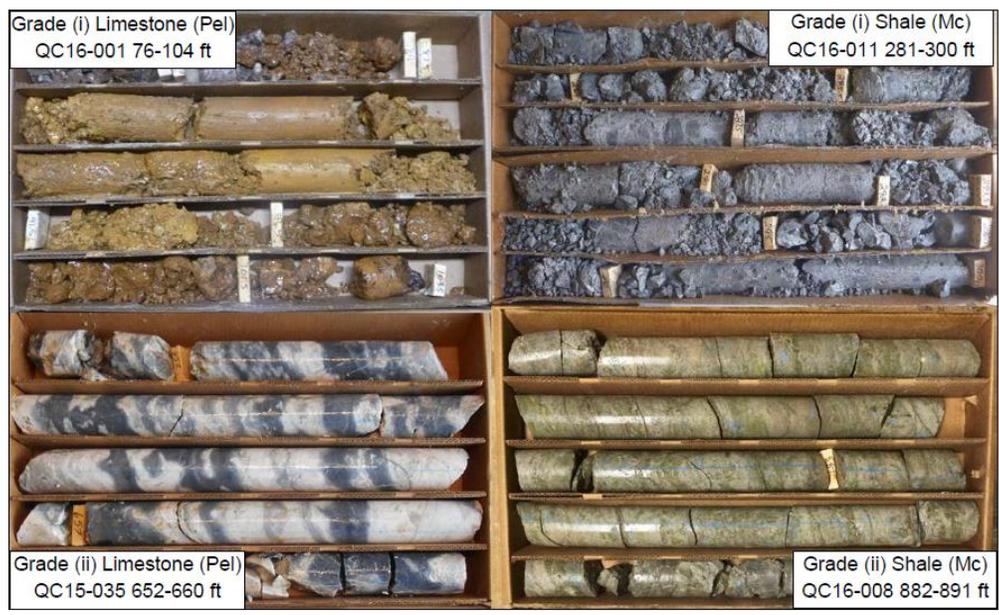
Figure 4. Comparison of rock mass quality between the alteration grades.

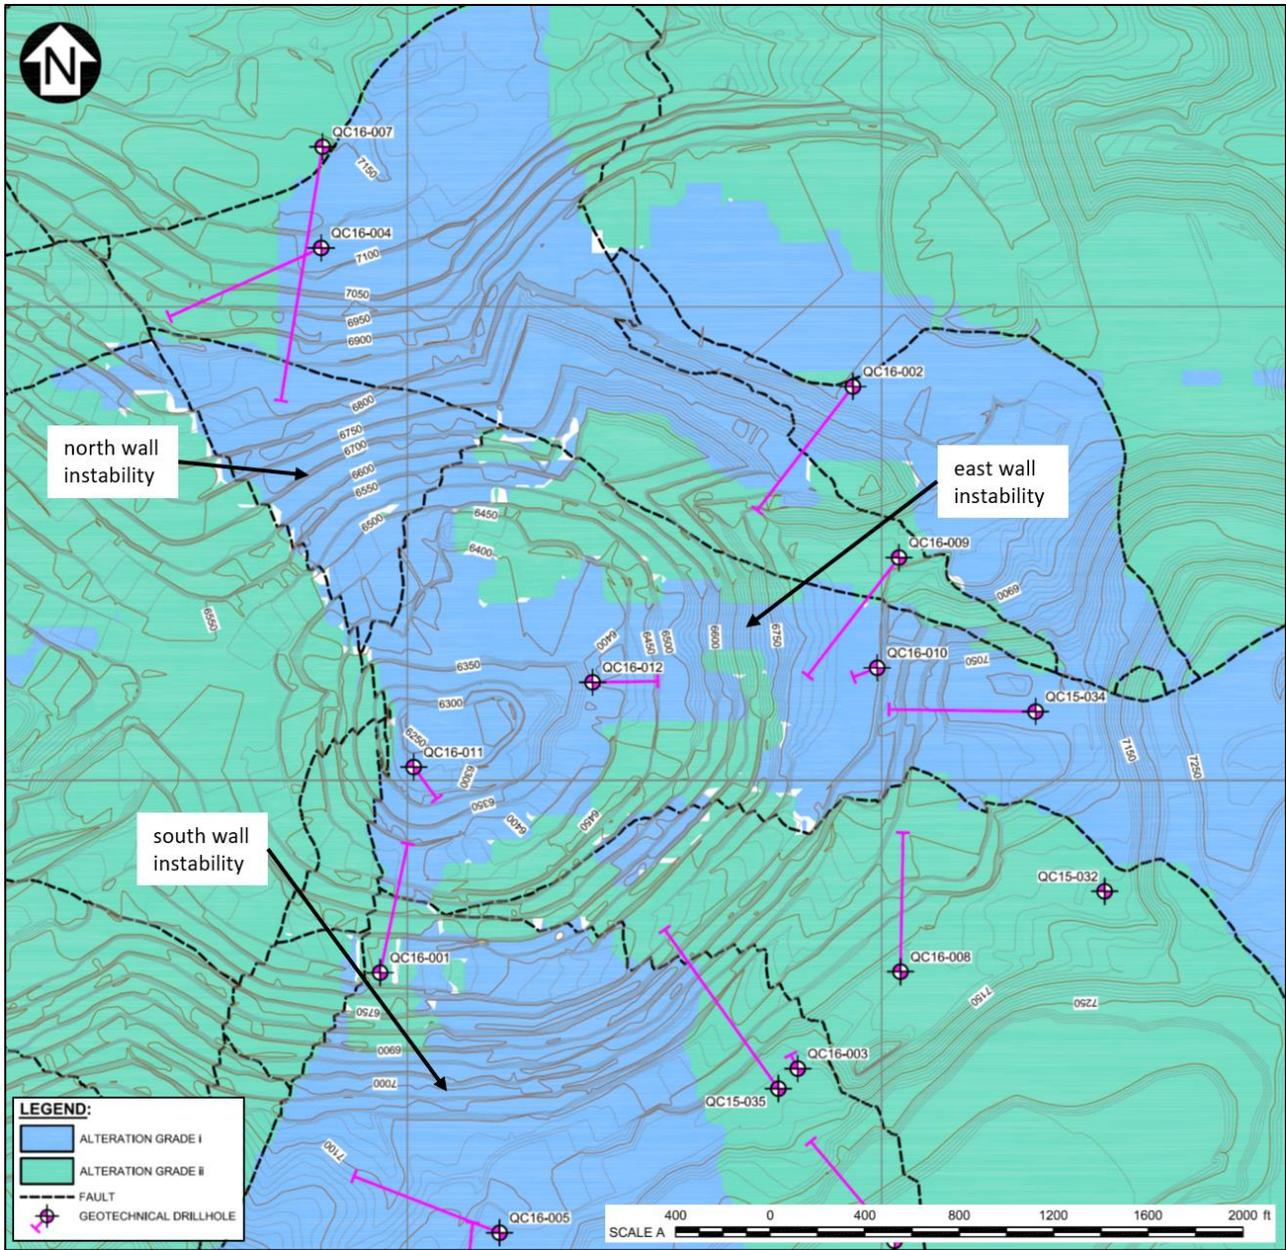
Site investigation data indicated that domaining by alteration grades provided a more meaningful understanding of the expected geomechanical response relevant to slope stability, as shown in Tables 1 and 2. Figure 5 shows that the areas of instability in the pit walls coincided with areas where the alteration was the weaker Grade (i) and indicated the rock mass was weak to medium strong (Table 1) and poor in quality (Table 2). The tabulated summary of strengths also suggests that intact rock fragments are stronger than the rock mass, which is an important consideration for developing analysis models.

Figure 5. Alteration grade map (2016 topography).

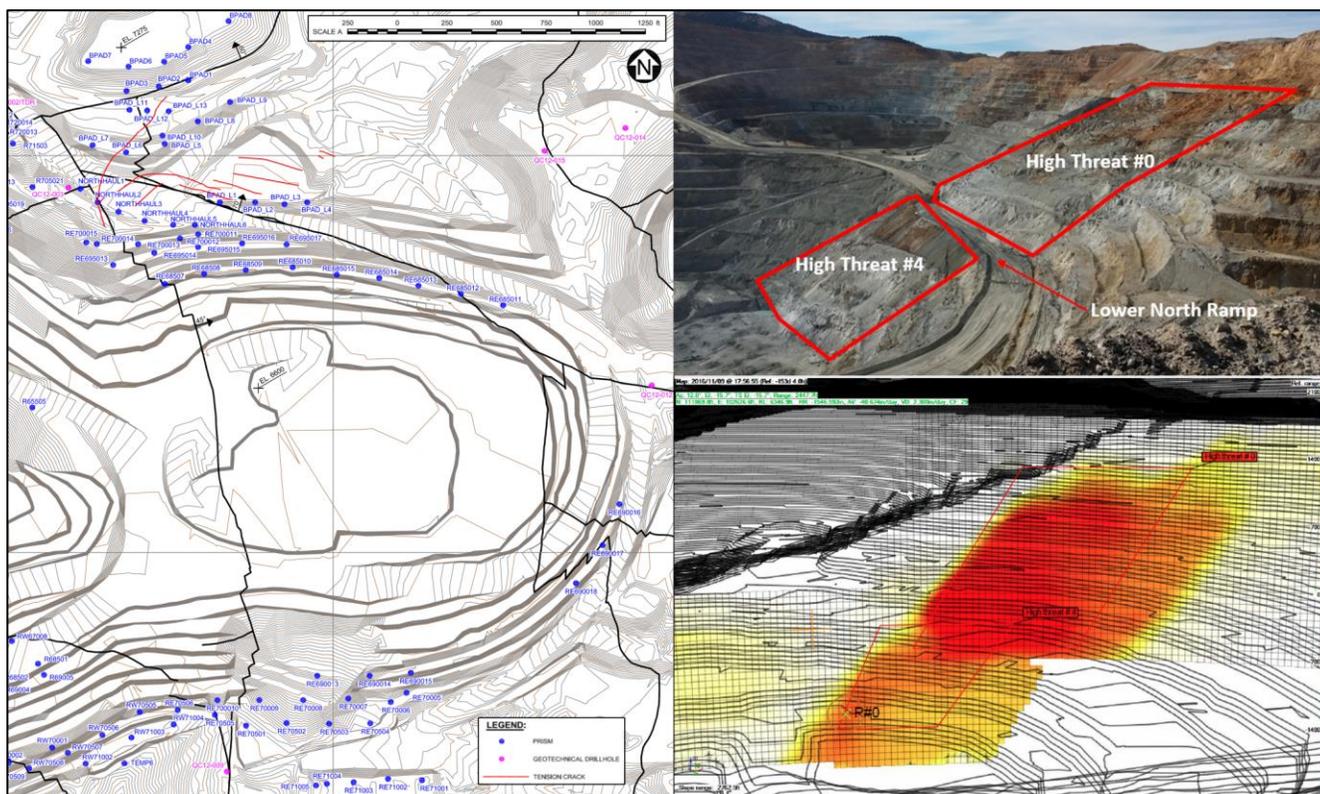
Figure 6. Displacement monitoring by survey prisms (left) and terrestrial radar (right).

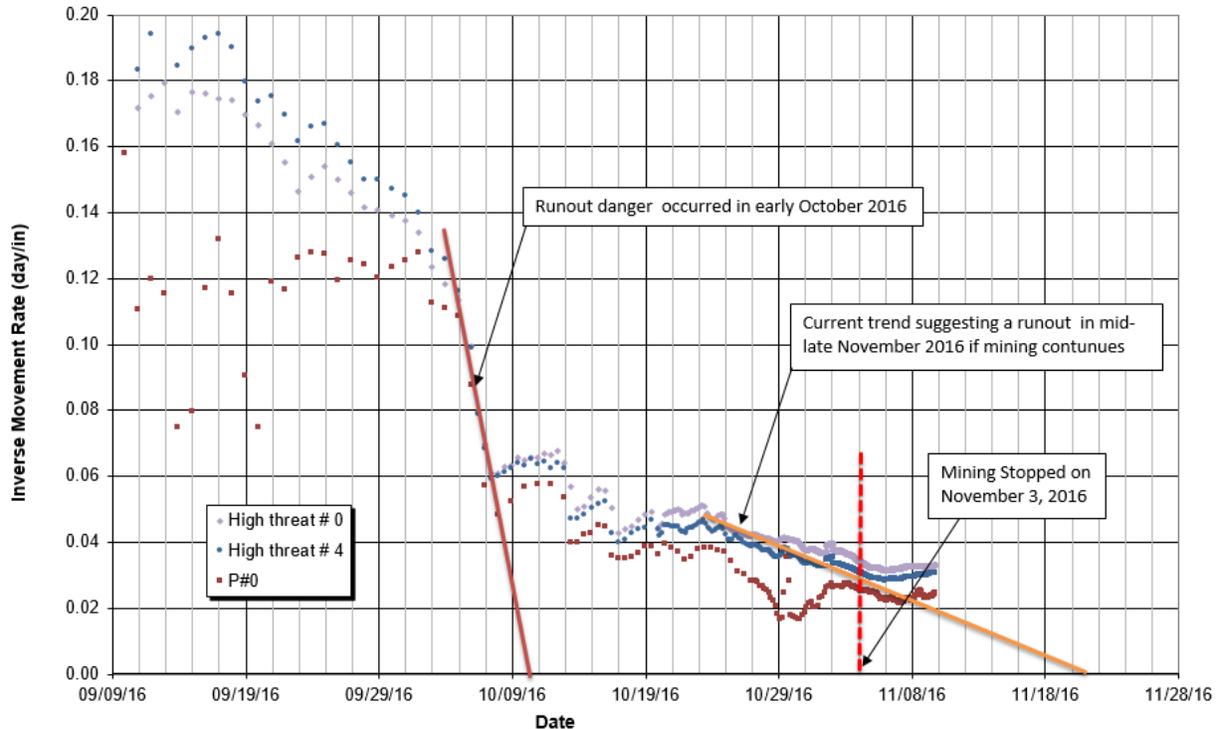
have an inverse velocity of zero. As shown in Figure 7, the inverse-velocity trends of the north wall suggested a runout danger in the beginning October 2016. However, mining was paused to repair the haul road and the inverse velocity trends flattened out then decreased incrementally when mining resumed. At the beginning of November 2016, the mine was advised to pause mining for a period until the deformation rate decelerated. Over this period, the north wall displaced approximately 30 inches per day.

Figure 7. Inverse velocity trends of the north wall 2016 instability.

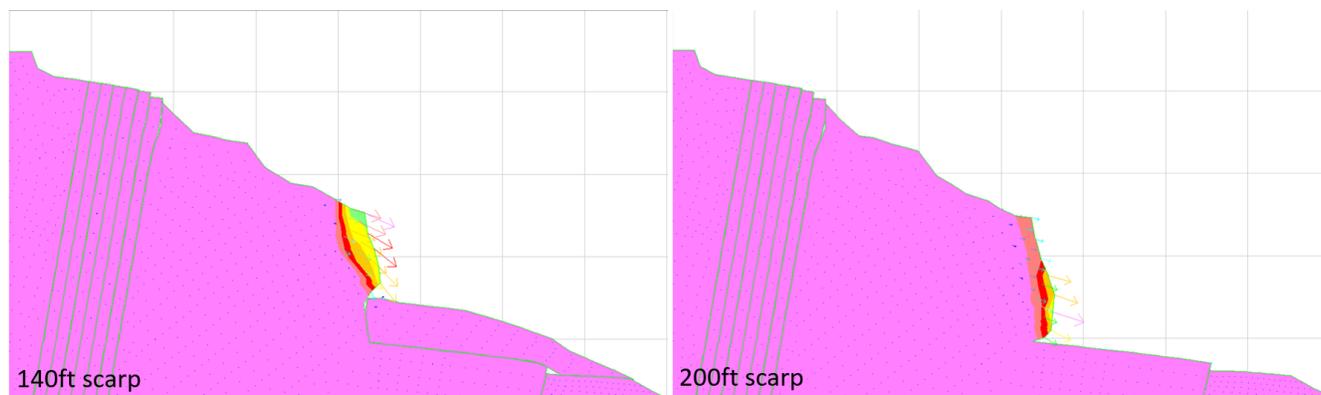
removing the slide debris at its base. The influence of the rock mass structure was evaluated with increasing complexity from only considering the faults to including a series of tension cracks with the faults and finally, the addition of relaxation joints to the model with the faults and tension cracks. The results of the first two scenarios that evaluated the influence of the rock mass structure suggested similar failure mechanisms, as shown on Figure 8. For the existing scarp height, the predicted failure is localized and could occur as slabs or blocks toppling onto the slide debris. Increasing the height of the scarp suggested the failure would also be localized but suggested a change of the failure mechanism to one of rotation at the base of the unsupported scarp. The third scenario, which included the addition of a shallower-dipping relaxation joint at the base of the scarp, represented an extremely adverse combination of structural features and would critically require a highly unlikely persistent joint to daylight at the base of the scarp. The predictions of the third scenario were not considered as a result.

Figure 8. Predicted displacement magnitudes and velocity vectors of the back scarp.

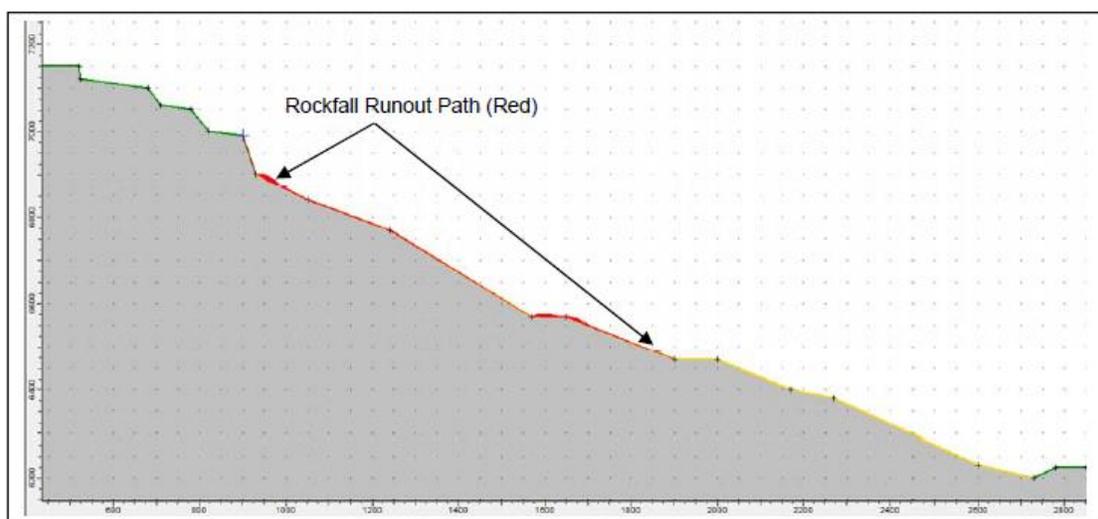
The rockfall hazard was also evaluated by considering two heights for the scarp. The model assumed falling rocks would initiate immediately above the back scarp and involve rock dimensions of 0.1 to 10 square feet (13 to 1,300 pounds). The results for 200 rockfalls are shown on Figure 9 for the existing scarp height, which predicted a longer runout distance. The rockfall runout was estimated to end near the proposed road alignment and a six-foot-tall rockfall barrier was recommended as a result. Increasing the scarp height was not predicted to generate higher energy rock fall due to a flatter talus slope that was assumed to form because of the creep.

Figure 9. Predicted displacement magnitudes and velocity vectors of the back scarp.

The stability assessment indicated the proposed road access could be re-established with a minor potential for rockfall that could be easily mitigated. Close slope monitoring was also recommended during construction, along with maintenance as needed.

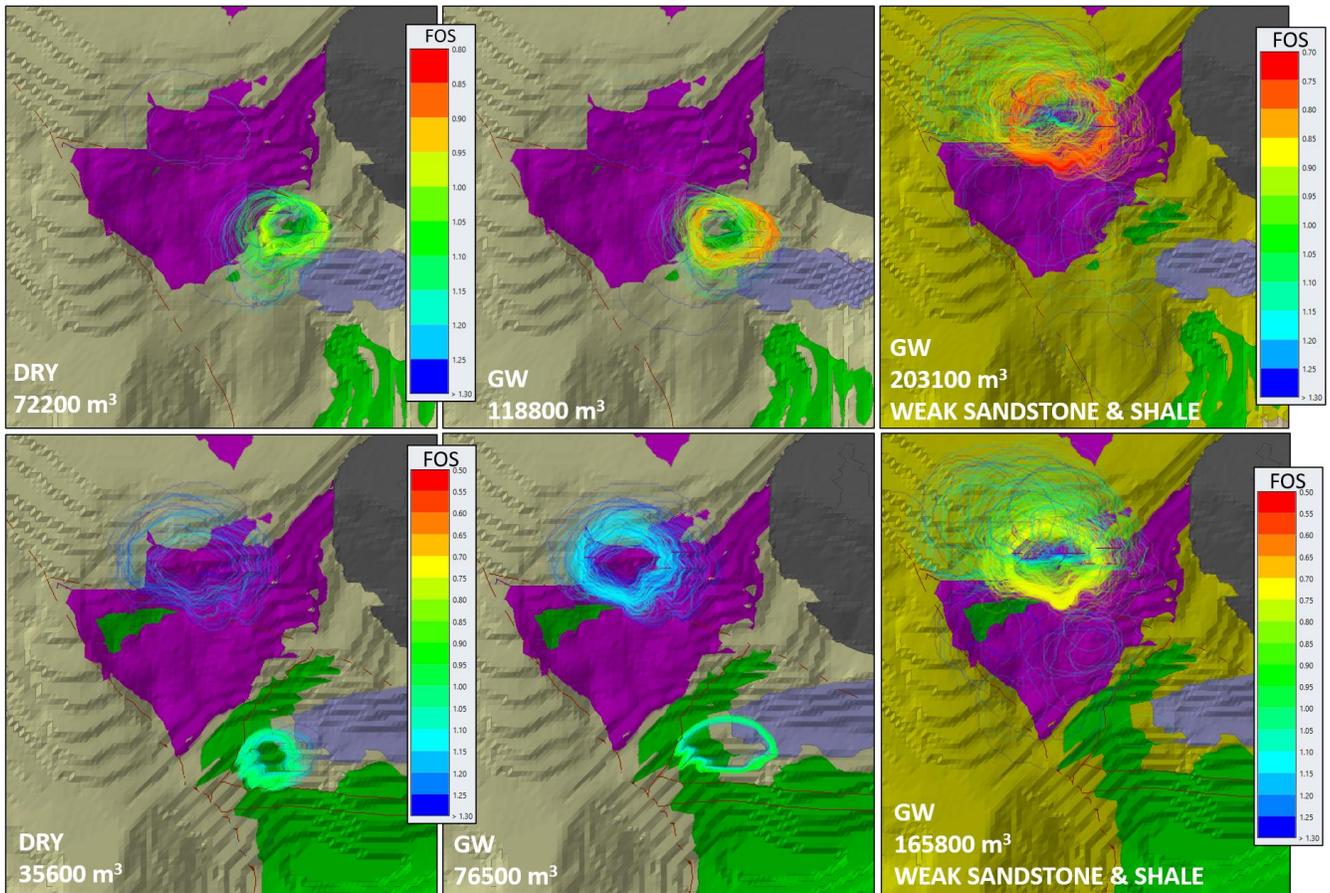
The modeling results are shown on Figure 11 and identified areas of concern for the 2018 geometry and the proposed mine plan for mining out the toe of the slide debris. The areas of concern for the 2018 pit were the upper and middle north wall, which coincided with zones of highest displacements captured by the radar unit. The lowest factors of safety were predicted near the nose with the adjacent pit (immediately above the original haul road) and the localized back scarp (evaluated previously) for both geometries. An additional area of concern for the proposed mine plan was identified near and below the north wall nose with the adjacent pit. Figure 11 also shows sensitivity checks completed for variable groundwater conditions and rock mass strength. In addition, a simplified stability evaluation of the toe of the slide debris was also completed (not shown) and indicated that stability was marginal.

Figure 11. Areas of concern identified by limit equilibrium analysis, 2018 pit (top) and toe removal (bottom).

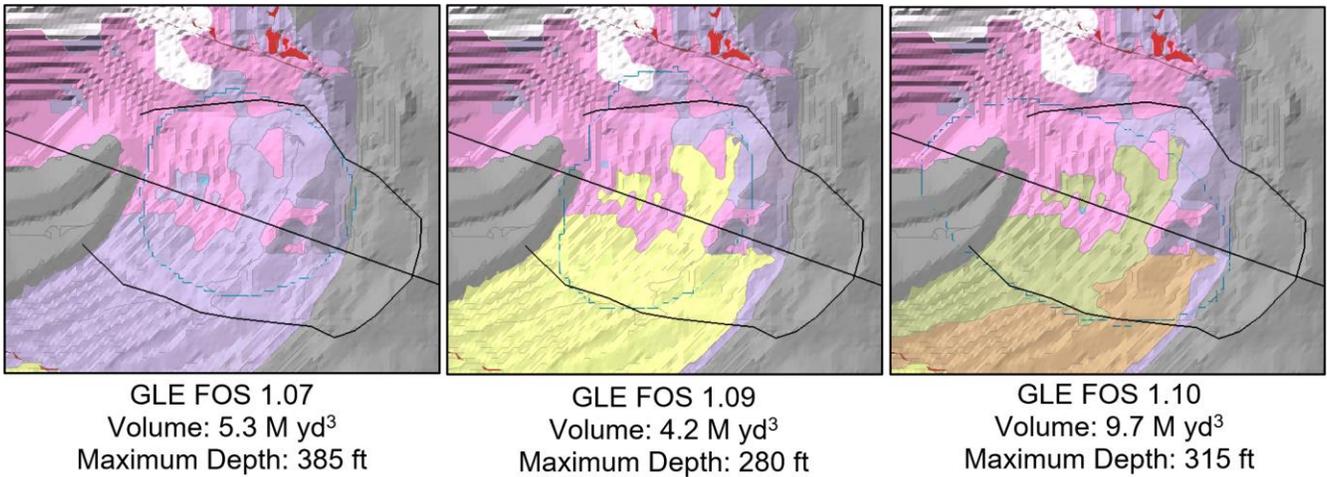
Attention turned to the pit's east wall since the mining strategy of the north wall was well-established. During completion of the proposed mine plan, a wall-scale instability occurred as weaker rock was exposed and an extremely wet spring elevated pore pressure conditions in mid 2019. A back-analysis of the east wall failure was completed with Slide3, which provided calibration of material strengths and piezometric conditions for the predictive analysis of the proposed end-of-mine design and the initial stage of backfill. This mine plan involved mining beyond the debris toe of the north wall instability, including the original haul road. Backfilling was to occur from a newly-established haul road along the south wall. The results shown on Figure 12 indicate stability was expected to be marginal, which implied careful monitoring and strategic mining were required to complete the end-of-mine design. The results of the initial backfill, to establish the new haul road, showed the buttressing effect of the backfill but also indicated the road switchback should be extended towards the northeast to better buttress the existing toe of the east wall instability. Elevated piezometric conditions were also shown to reduce the factor safety and improved drainage of the rock mass was recommended as a result.

Figure 12. Factors of safety prediction for east wall failures for the end-of-mine plan with initial backfill.

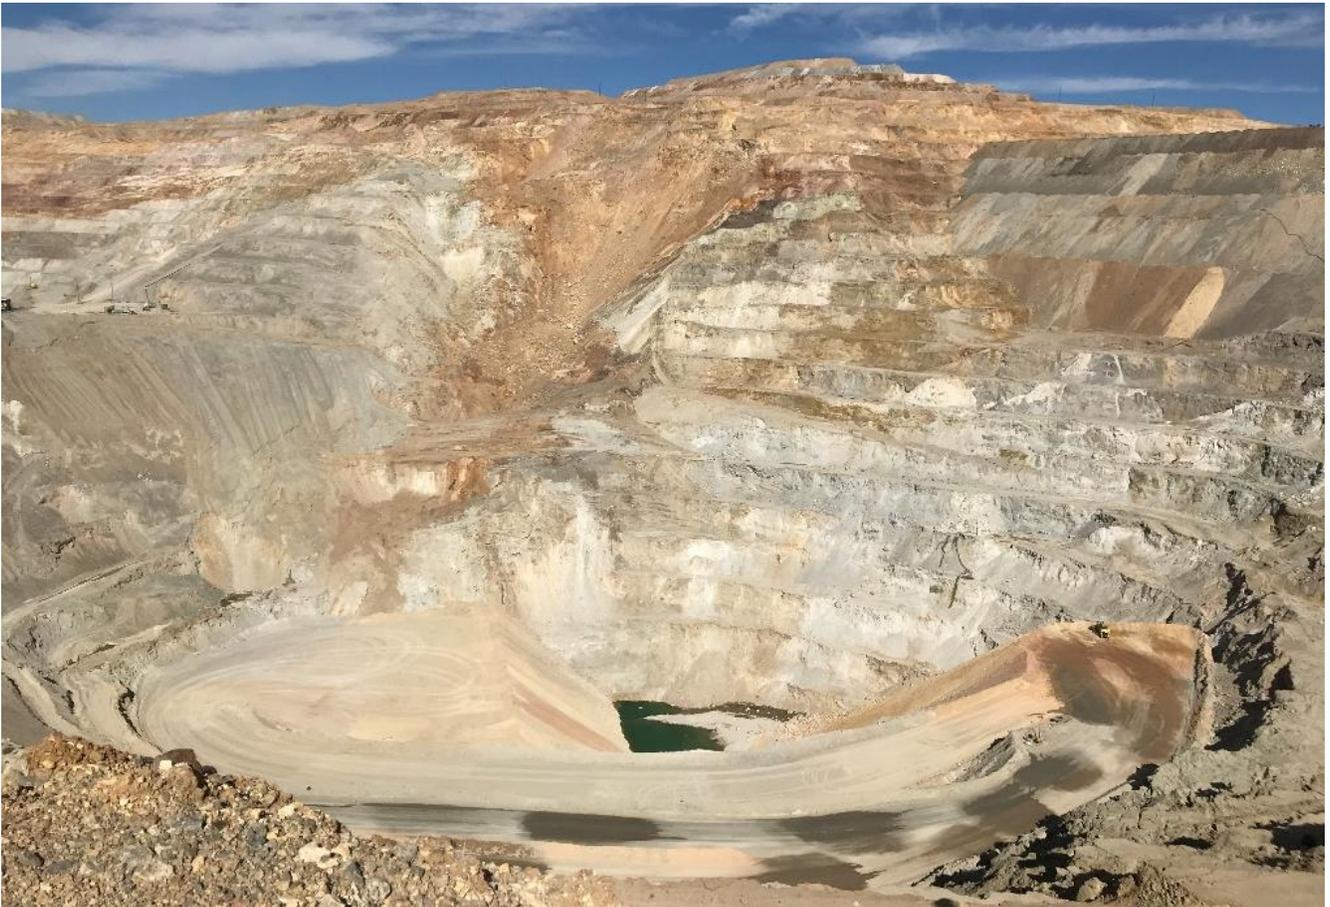
Figure 13. Overview of the north wall after mine completion (late 2020).
