PROCEEDINGS OF TAILINGS AND MINE WASTE 2015 CONFERENCE

Assessing credible modes of failure: Afton TSF dam breach study

Anna Akkerman, P.Eng, Violeta Martin, P.Eng, Ph.D,
Knight Piésold Ltd., Vancouver, BC, Canada

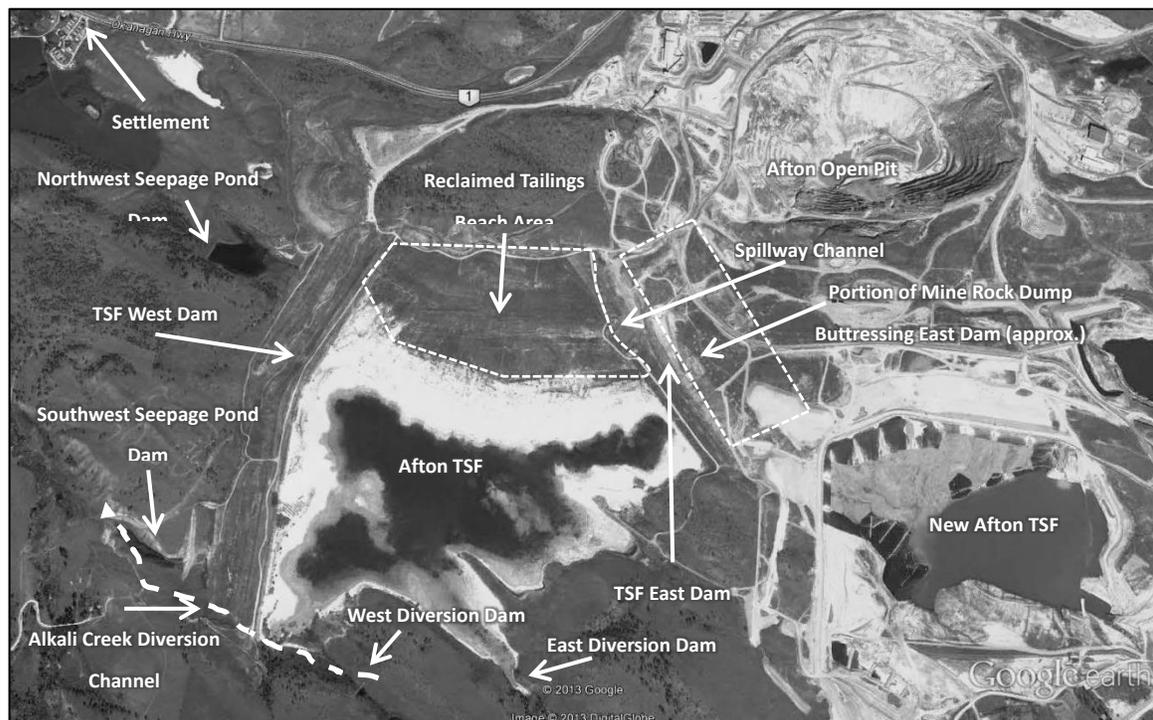
Figure 2: Afton TSF – General Arrangement

The general arrangement of the Afton TSF is shown on Figure 2. The Afton TSF consists of the following major components:

- Two zoned earthfill/rockfill dams with engineered filter zones. The two dams are referred to as the East Dam and the West Dam. The East Dam is classified as HIGH hazard and the West Dam as EXTREME (KP 2014a). The West Dam is further divided into the north section and the south section.

The north end of the Afton TSF has beaches developed to the dam crest elevation of 706 m with no potential for water storage in that area of the TSF. This beach area, as shown with a polygon on Figure 2, has been reclaimed. Part of this reclaimed area is shown on Figure 6.

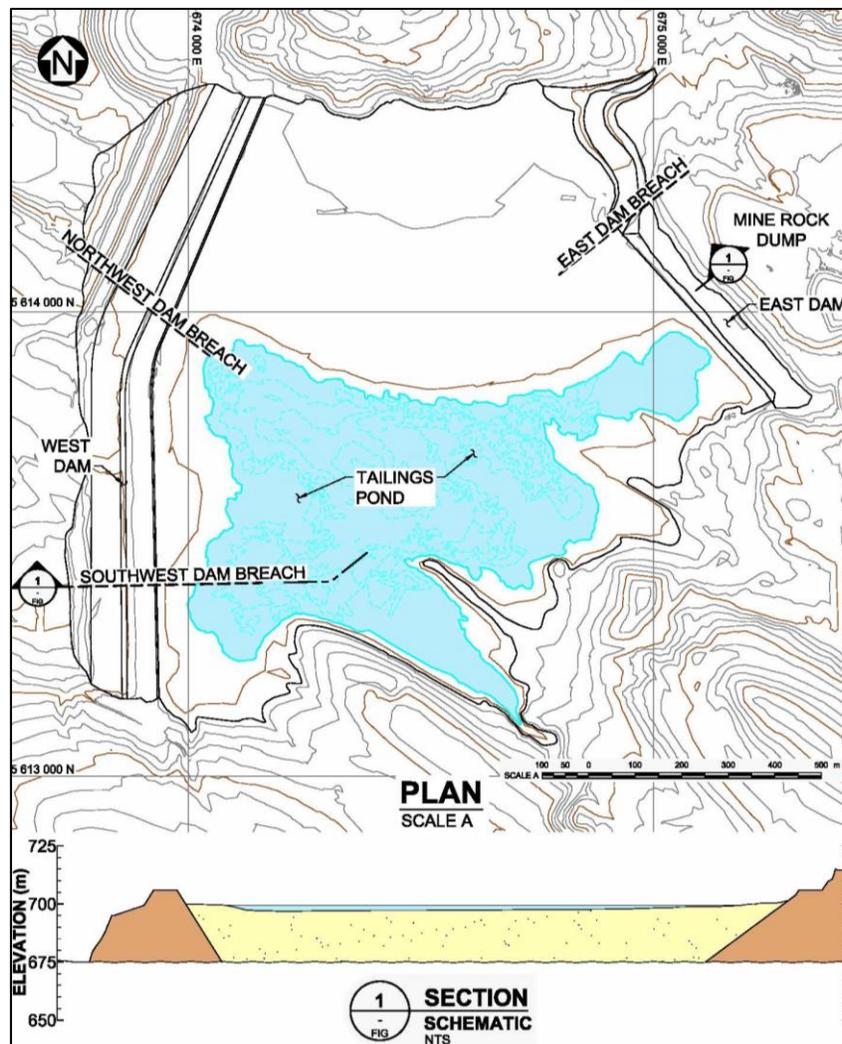
Figure 3: Afton TSF Plan and Section

A layout and schematic cross section of the Afton TSF are presented on Figure 3. The Afton Mine ceased operations before reaching the full mine life and the dams were never raised to their ultimate design height. Consequently, the dams were overbuilt in terms of crest width, which is approximately 100 m at an elevation of 706 m. Table 1 outlines the TSF embankment parameters for each dam and the spillway. A portion of the East Dam is buttressed by a mine rock dump that is higher than the East Dam itself, as shown in the section on Figure 3, which makes the dam particularly stable in that location. Furthermore, it is worth noting that the West Dam was constructed with relatively flat downstream slopes (flatter than 2H:1V).

the largest outflow volume and the highest peak discharge, and therefore represents the worst case scenario. However, failure through the deepest dam section does not represent the worst case breach location for the Afton TSF. The highest dam wall for the Afton TSF is the West Dam at its north end. A large area along this end of the West Dam, including the deepest dam section, has a reclaimed tailings beach developed to the crest of the dam. A pond cannot form adjacent to the dam in this area because of this reclaimed tailings beach area. Considering that the pond water cannot reach this area, a failure of the dam through this deepest section would not result in the largest possible outflow flood wave and associated downstream inundation in either the sunny day or the flood induced scenario. For that reason, a hypothetical failure location was selected closer to the middle section of the West Dam in an area where the tailings beach is not developed to the dam crest elevation. This hypothetical failure location is identified as the Northwest Dam Breach on Figure 3.

The south end of the West Dam is located across a tributary catchment to Cherry Creek. This section of the West Dam has a tailings beach developed to approximately 6 m below the dam crest, and a pond may develop adjacent to the dam. Accordingly, a hypothetical breach location was chosen through the deepest section of this part of the West Dam, which is identified as the Southwest Dam Breach on Figure 3.

The East Dam is largely buttressed by a mine rock dump that is higher than the dam itself (Figure 3), while the north end of the East Dam has a reclaimed tailings beach developed to the crest of the dam. Therefore, the only credible location for a potential breach of the East Dam is the spillway location, which is identified as the East Dam Breach on Figure 3.

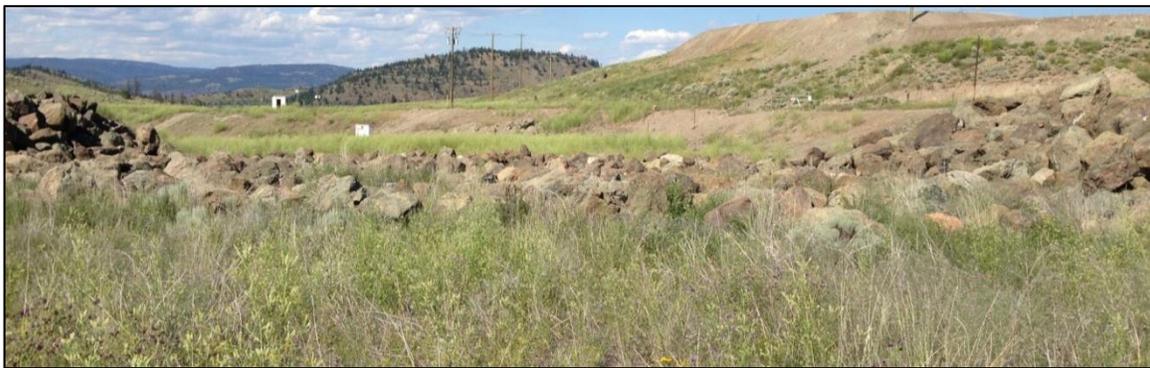
The spillway invert was constructed 2 m below the dam crest in the East Dam and was designed to pass the Probable Maximum Flood (PMF). The spillway consists of a 50 m wide riprap lined opening in the East Dam that transitions to an unlined earthen channel, as shown on Figures 4 and 5. The spillway channel curves along the toe of the East Dam and leads to a set of five culverts that discharge onto a haul road that runs along the perimeter of the Afton Open Pit. The tailings beach at the entrance to the spillway has been reclaimed.

Figure 4: Riprap lined spillway entrance with reclaimed tailings beach in the foreground and mine rock dump on the right side of the frame, looking downstream (northeast)

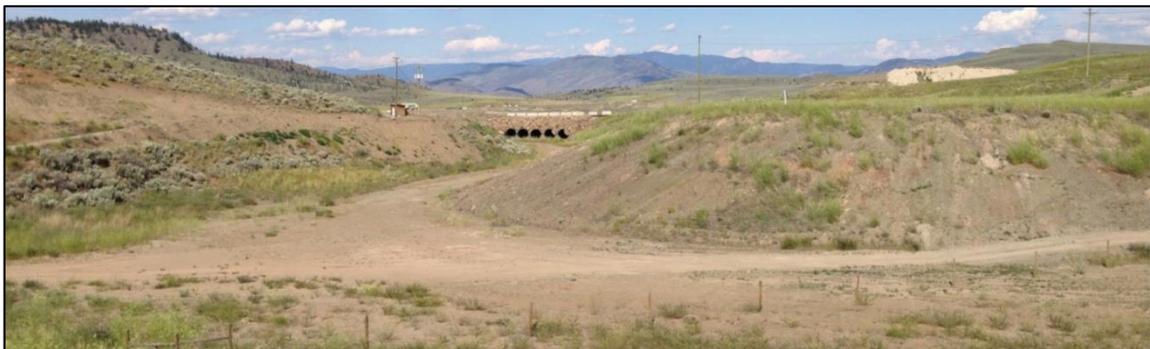
Figure 5: Spillway channel with roadway crossing in background, looking downstream (northeast)

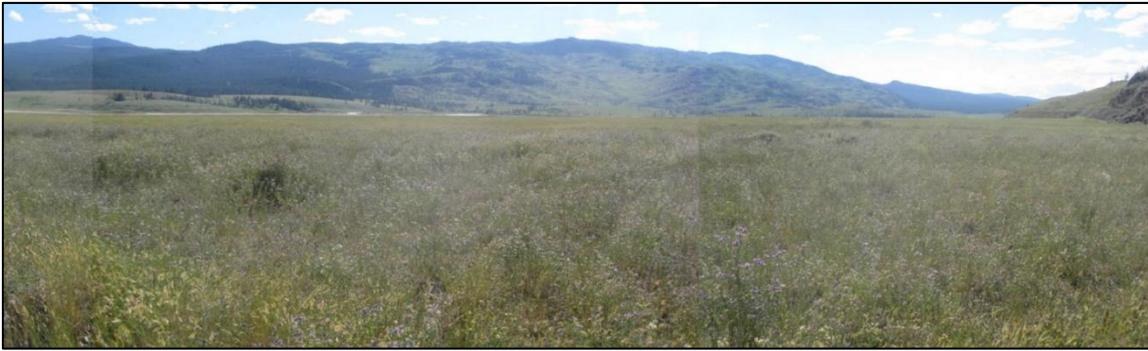
Figure 6: Reclaimed tailings beach, looking southwest from the north end of the East Dam

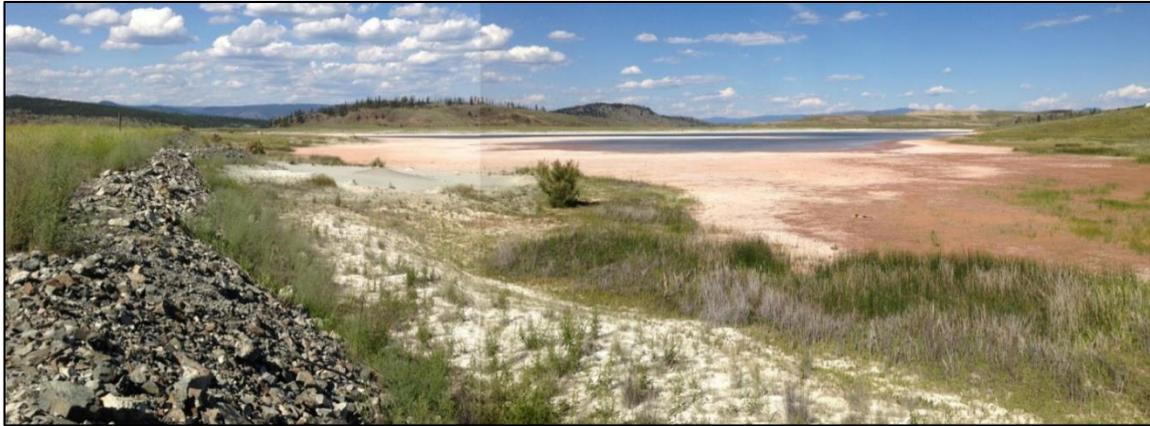
The 2013 Dam Safety Review estimated the pond water level to be at elevation 699.5 m based on 2013 LiDAR topography (KP 2014a) as shown on Figure 7. This level equates to a freeboard of 6.5 m to the dam crest and 4.5 m to the spillway invert. In 2014, the pond level was assessed to be at an elevation of between 699.5 m and 700.0 m (KP 2014b). The slightly higher water level in 2014 was attributed to the Alkali Creek Diversion Channel construction program, which included the temporarily diverted flow from the diversion channel into the TSF during the channel upgrades (KP 2014b). Given the observed water levels, the facility layout and the local climate, the authors estimate that a freeboard of about 4 m to the spillway invert and 6 m to the dam crest will likely be available throughout most of the year.

Figure 7: TSF pond on July 9, 2013, looking northeast.
