Von Bach Dam Receives Major Facelift

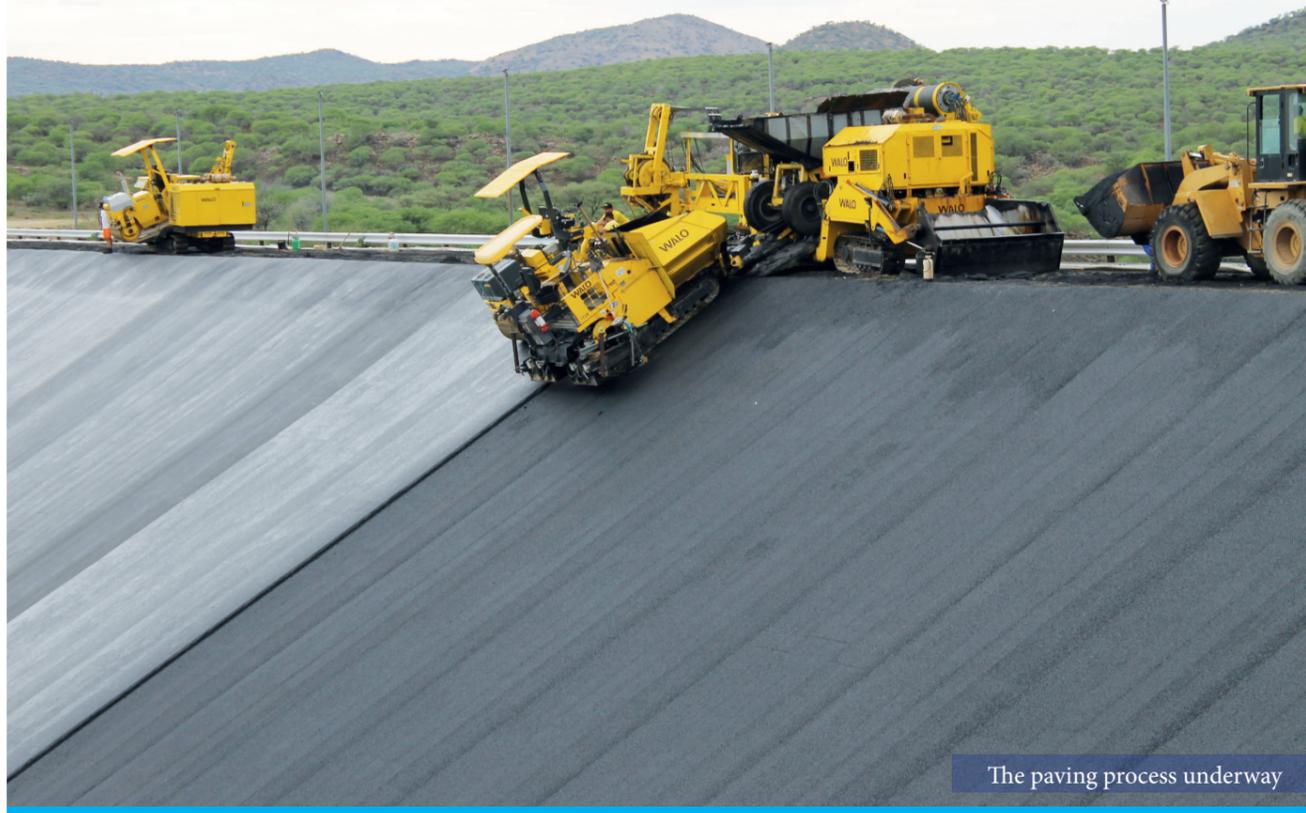
The paving process underway

Construction work entailed milling away a significant portion of the old asphalt membrane, and replacing it with a new 70mm thick asphaltic drainage layer and a new 70mm thick dense asphaltic seal (also referred to as dense asphaltic concrete (DAC)). Batching of the new asphalt was performed by a sub-contractor, MUCH Asphalt, at their batching plant at the Aris Quarry, south of Windhoek.

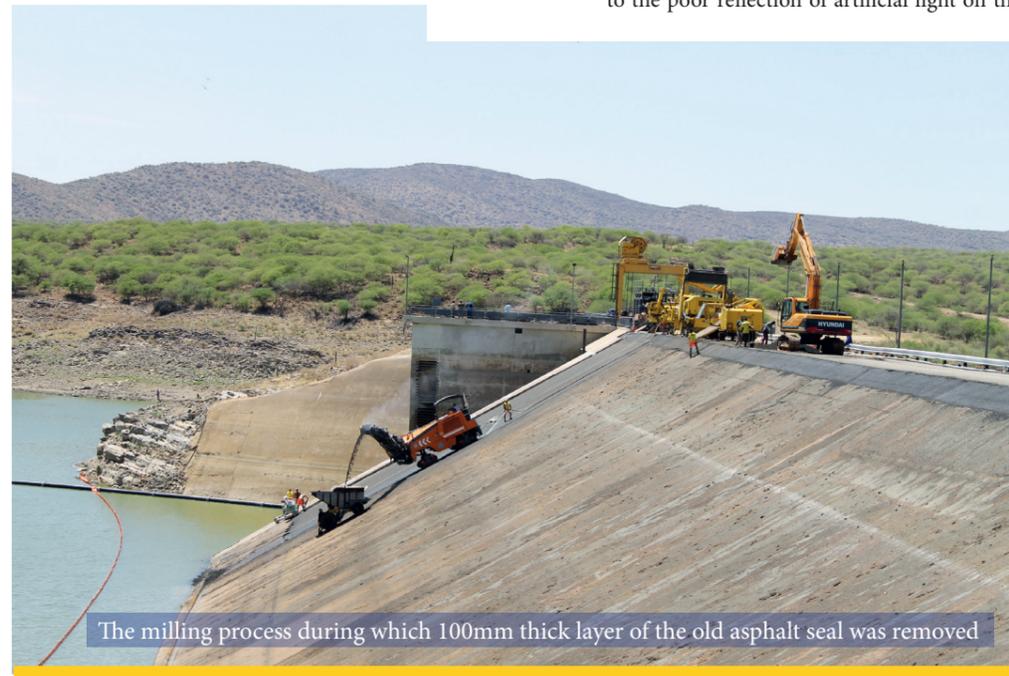
The milling process during which 100mm thick layer of the old asphalt seal was removed

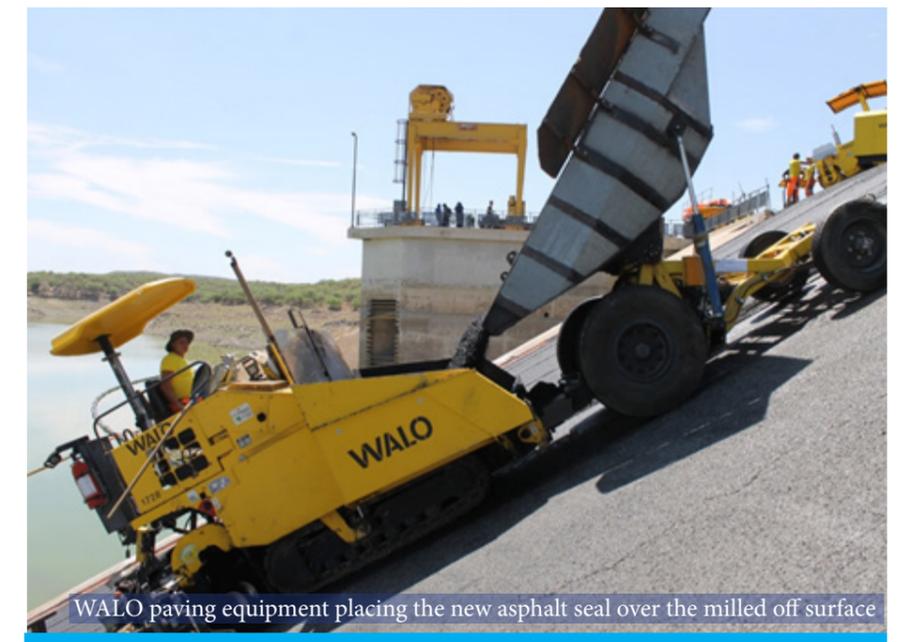
WALO paving equipment placing the new asphalt seal over the milled off surface
