# Landslide Risk Management for the Construction and Operation of the Upper Lillooet River Hydroelectric Facility near Pemberton, BC

James Haley P.Eng.  
*Knight Piésold Ltd. Vancouver, BC, Canada*  
Pierre Friele P.Geo.  
*Cordilleran Geoscience, Squamish, BC, Canada*

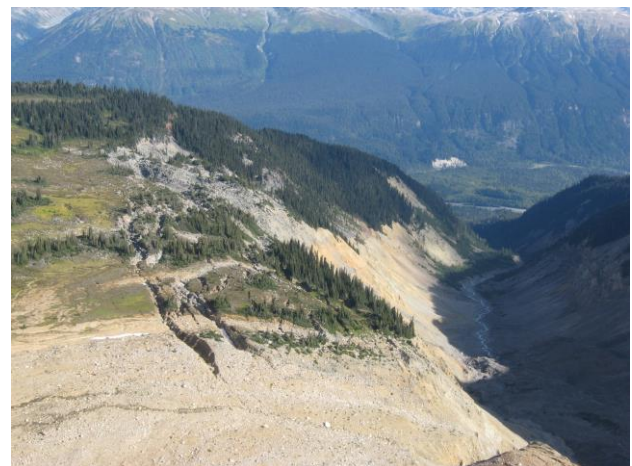
An area of sacking features was identified on the high, north-facing slopes of Plinth Peak in the Upper Lillooet River HEF Terrain Hazards Assessment report (KP 2011). The largest instability potentially affecting the project site is on the west flank of Plinth Peak, which forms the east sidewall of Job Creek. Roberti et al. (2018) mapped tension cracks in this area, and using remote sensing methods measured slope displacements of up to 17 mm/yr from 1992 to 2000 and deformation of 40 mm over a 24-day period in July and August 2016. Roberti et al. (2018) show there has been considerable depletion of the glacier at the slope toe between 1987 and 2016, and infer that collapse of this slope could generate a  $10^8$  to  $10^9$  m<sup>3</sup> landslide. Additional sacking features were mapped in the Job Creek catchment in the Upper Lillooet River HEF Terrain Hazards Assessment report (KP 2011). An extensive area of sacking features with extensive tension cracks is documented on the west side of Affliction Creek (Read 1978, Bovis 1990, Jordan 1994). Over a period of seven years, Bovis (1990) recorded 1 to 5 m of horizontal movement and up to 4 m of vertical displacement across individual tension cracks (i.e. movement of several 10's cm to almost 1 m/yr). Photo 1 shows this area.

Photo 1. Sacking features with extensive tension cracks in the Affliction Creek Catchment.

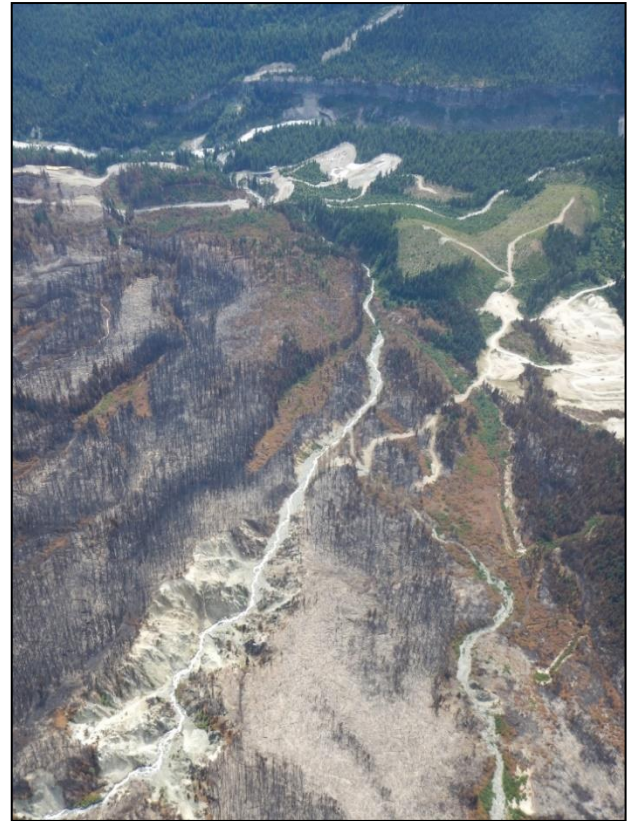
the canopy trees blackened. Photo 2 shows the vegetation burn in the Truckwash Creek catchment:

Photo 2. Predominantly High vegetation Burn Severity in the Truckwash Creek Catchment from the 2015 Wildfire
