The essence of material compatibility in advanced barrier systems of existing TSFs

V. Govender¹, E. Zannoni.²

¹Knight Piésold, Johannesburg, Gauteng, South Africa.

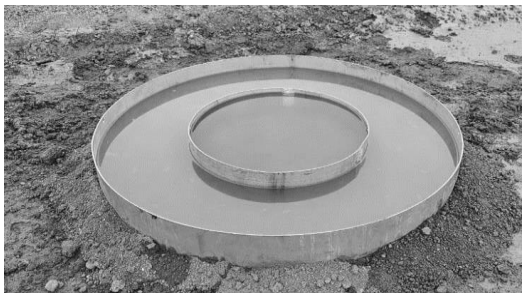
Fig 3. Double ring infiltrometer test apparatus

The double ring infiltrometer test, as illustrated in Figure 3, is an adaptation of Parr and Bertrand (1960), widely used to determine the infiltration rate of soils, which further enables the designer to calculate the permeability of the in-situ material. The resulting permeability for both the Hillwash and Residual Norite were analyzed based on the known (Philip, 1957)

infiltration equations and were found to be in the order of 1×10^{-6} to $1 \times 10^{-8} \text{ ms}^{-1}$ which classified to “Lowly Permeable” and satisfied the design criteria. Measurements were taken once the soil was fully saturated, after a 24-hour period and recorded in intervals of 10 – 360 minutes until a steady state of permeability was achieved.

An ideal foundation should be impermeable to lowly permeable, to prevent an excessive amount of seepage. As part of the Material Quality Assurance (MQA), double ring infiltrometer tests were recommended on the footprint of the buttress to determine the saturated hydraulic conductivity of the subgrade. The tests were conducted on various sections due to the wide variation of in-situ soils contained on site; mainly consisting of Reworked Residual Norite – Black Turf and Hillwash, containing traces of sandy gravel material.

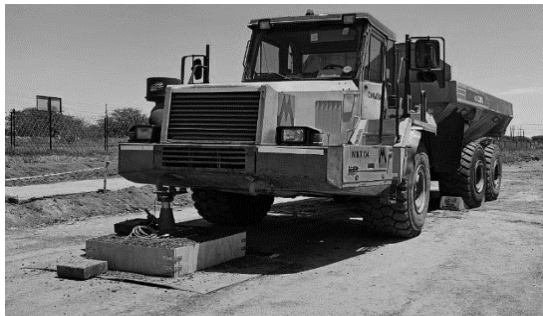
A 1500 g/m^2 polyester continuous filament protection geotextile has been specified to limit the amount of strain induced by the buttress material ($D_{\text{max}} 24\text{mm}$) onto the underlying geomembrane, of which in accordance with (Hornsey, 2023) emulates a 2200 g/m^2 polypropylene geotextile. To further analyze the strain effects in the Geomembrane, a test pad was constructed on site as illustrated in Figure 4.

Fig 4. Test pad under construction to monitor damage and strain in the Geomembrane

Due to the site topography and the wide variation of in-situ soils mainly consisting of Low Plasticity Clay (Hillwash) and Clayey Sand (Residual Norite), the level of strain generated in the geomembrane varied with the compaction of the subgrade.

The first test was conducted on the Hillwash with a load of 500kPa (full height of the buttress) over a 24-hour duration, and from the results obtained, using the (Tognon et al., 2000) method, the amount of strain generated in the geomembrane calculated to be 1.5% which falls below the threshold value of 3%, at which the geomembrane would exhibit stress cracking potentials (Seeger et al., 2003).

For the Reworked Residual Norite, three strain test pads were set up and conducted for varying compaction efforts of 85, 90 and 93% Modified Proctor as shown in Table 3. From the results obtained for three scenarios, the risks of a less dense surface could easily be identified and allowed for acceptable range to be agreed on should the contractor develop challenges in obtaining the specified density.
