Design of Zinc Tailings Storage Facility

A. du Plessis¹

¹Knight Piésold Consulting, Johannesburg, Gauteng, aduplessis@knightpiesold.com

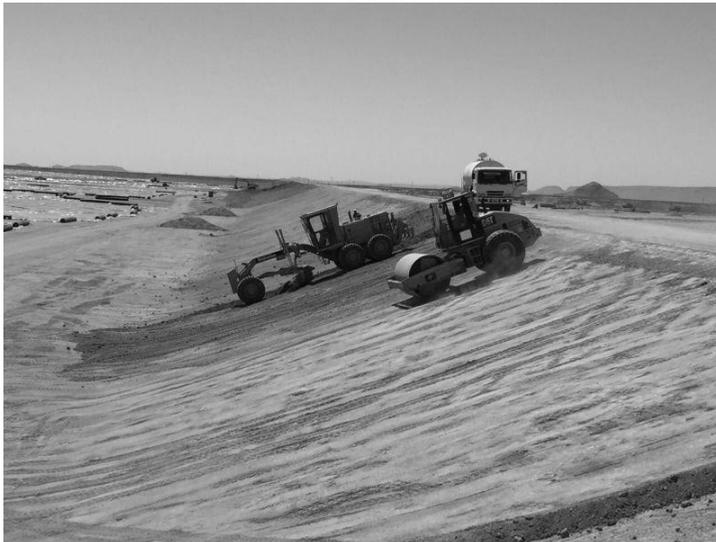
Figure 5. TSF Starter wall compaction

- Compacting the side slopes of the walls to the required compaction and smoothness proved to be difficult and an additional sand layer had to be placed on the side slopes as presented in Figure 5.

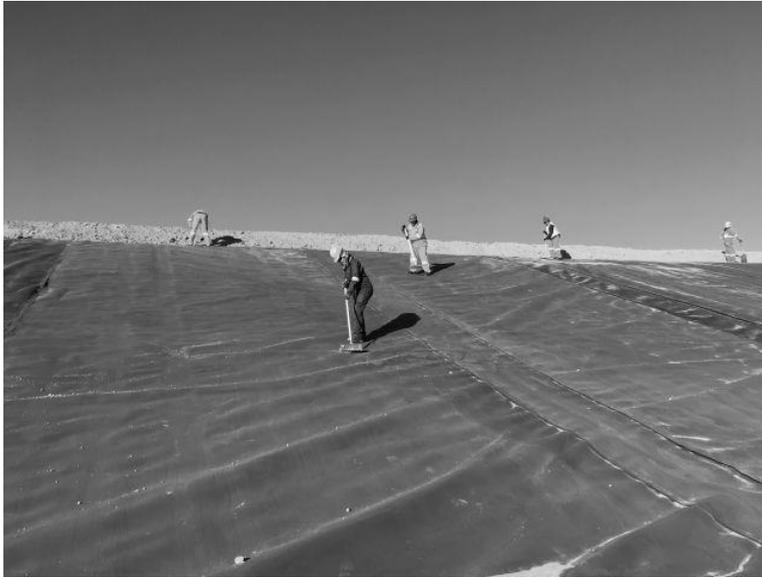
Figure 6. TSF Starter wall cleaning

- The “road building” material placed on top of the wall, was difficult to keep in place and additional geotextile material had to be used to envelope the material and the liner had to swept a number of times as shown in Figure 6.
