Managing Excessive Pit Wall Deformation of Weak Rock Mass

Salina Yong *Knight Piésold Ltd., Vancouver, Canada*

Justine Ealy, Christina Foster *KGHM, Ruth, USA*

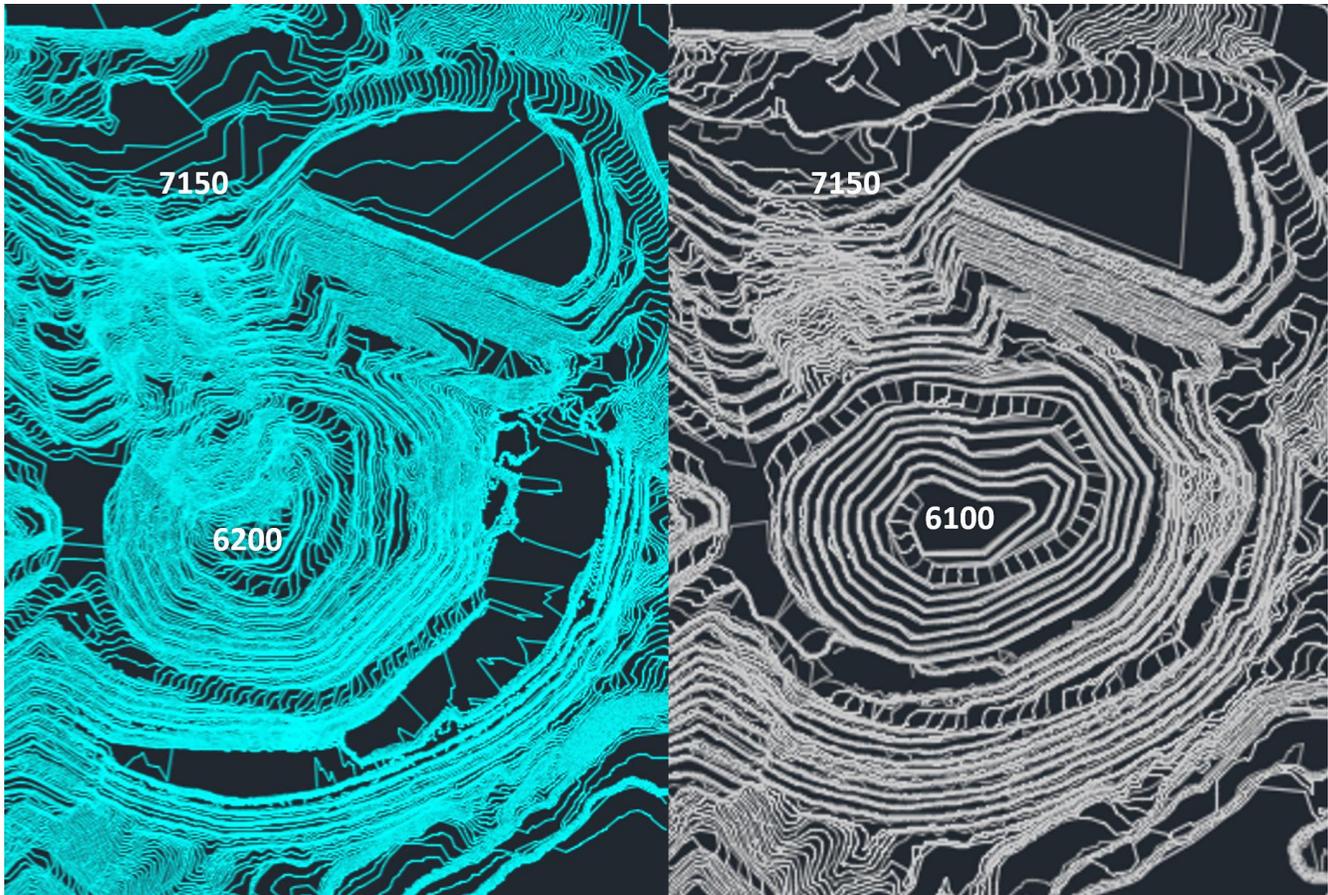
The potential risk of the proposed mine plan (Figure 10) for removing the toe of the slide debris of the north wall instability was evaluated by completing a three-dimensional limit equilibrium stability analysis using Slide3 (Rocscience 2018). The stability assessment considered four scenarios to evaluate the sensitivity of both the 2018 pit geometry and proposed mine plan to piezometric conditions.

Figure 10. 2018 geometry of the pit (left) and the proposed mine plan (right).
