KLAMATH RIVER RENEWAL PROJECT - DAM BREACH ANALYSIS USED FOR DESIGNING THE FINAL BREACH OF THE IRON GATE DAM

ABSTRACT

The Iron Gate Dam (IGD) is the most downstream dam of the four facilities of the Klamath River Renewal Project (Nistor et al. 2025). It was partially removed with conventional deconstruction techniques. Due to site and drawdown schedule constraints, the final remaining portion of the IGD had to be breached with a head difference of approximately 23 ft (7 m). The assessment of the planned breach and the final IGD reservoir release is presented in this paper. The range of peak outflows during the intentional breach phase was assessed for variable inflow conditions with the goal to establish the most sensitive and limiting breach parameters for safe final breaching and reservoir release. The design of the breach plug and breach channel through the remaining IGD dam incorporated the findings from the breach analysis and included a predefined cross sectional geometry and placed riprap, with the goal to have a peak breach outflow within the allowable flow limits. The final breach was initiated on August 28, 2024. The breach plug slowly eroded, requiring encouragement fr

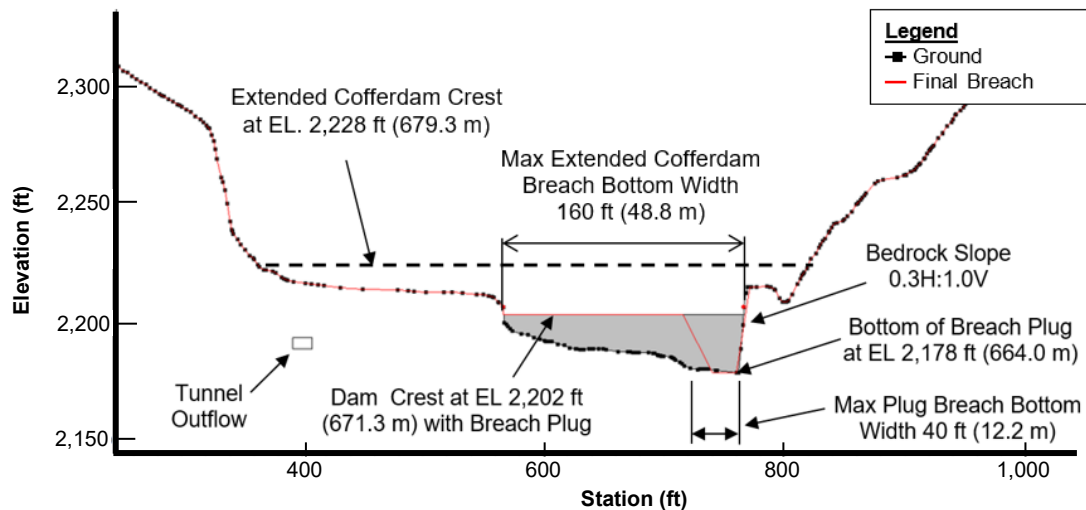
The breach plug was to be located at the right abutment at the deepest section of the dam. This approach would take advantage of the bedrock side slope as a physical limitation of the breach growing laterally towards the right (a “one-sided” breach). The bottom width of the plug would have been limited to approximately 40 ft (12.2 m) by the shape of the bedrock along the reservoir bottom. The cross-section used for breach modelling and the maximum bottom width of the breach based on terrain geometry at the dam are shown on Figure 1. The breach plug geometry was determined using the analysis discussed in the subsequent sections.

Figure 1: Iron Gate Dam and Breach Plug Cross-Section Relevant to Final Decommissioning Phase

The method in Table 1 is indicated as “deterministic” for the parameter values driven by the terrain geometry, or “probabilistic” for the conditions where a range of values was evaluated. The “uniform” distribution indicates that the selection of the parameter value within a given range was completely random. The right side breach slope is limited to the slope of the bedrock, as shown on Figure 1.

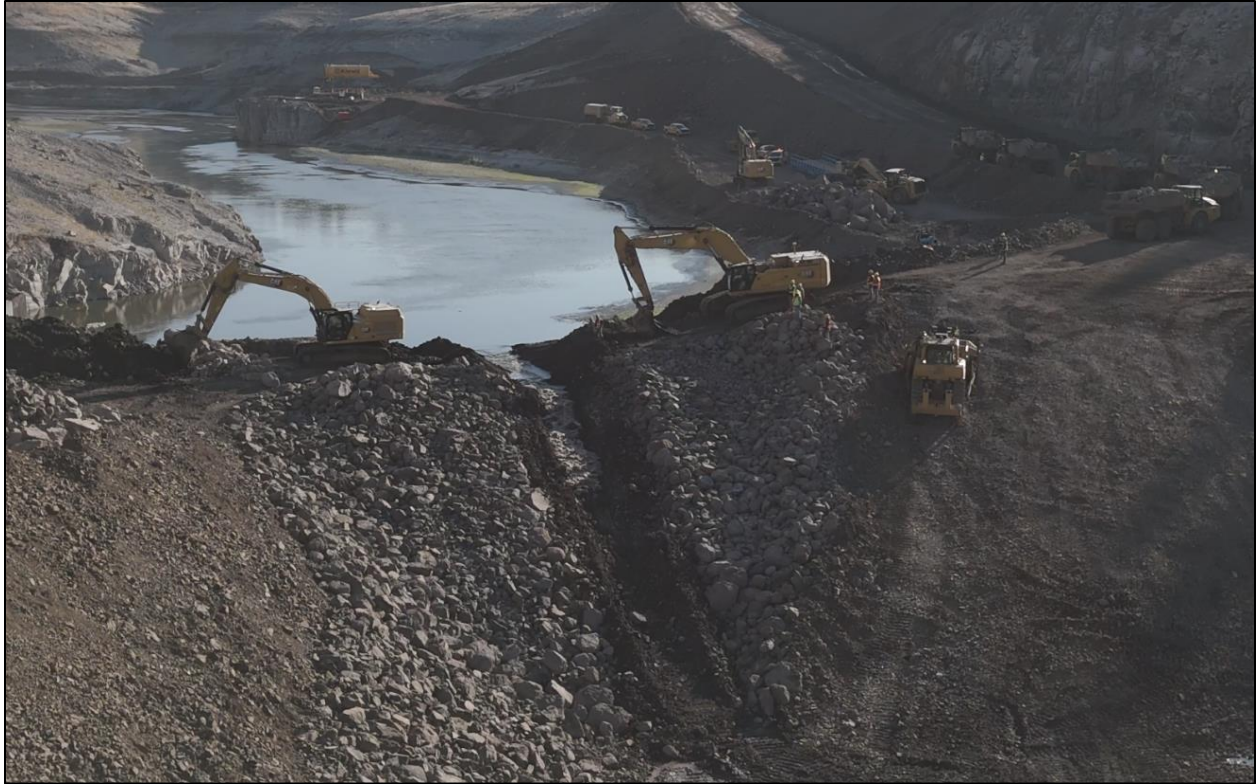
The reservoir reached the desired level by August 28, 2024. The breach was initiated using a long arm excavator at 8:21 AM. The breach channel eroded relatively slowly throughout the day. A photo of the breach initiation is shown on Figure 6.

Figure 6: Breach Initiation with Long Arm Excavators
