Reducing the Long Term Risk and Enhancing the Closure of Tailings Impoundments

A. Adams & C. Hall

Knight Piésold Ltd., North Bay, Ontario, Canada

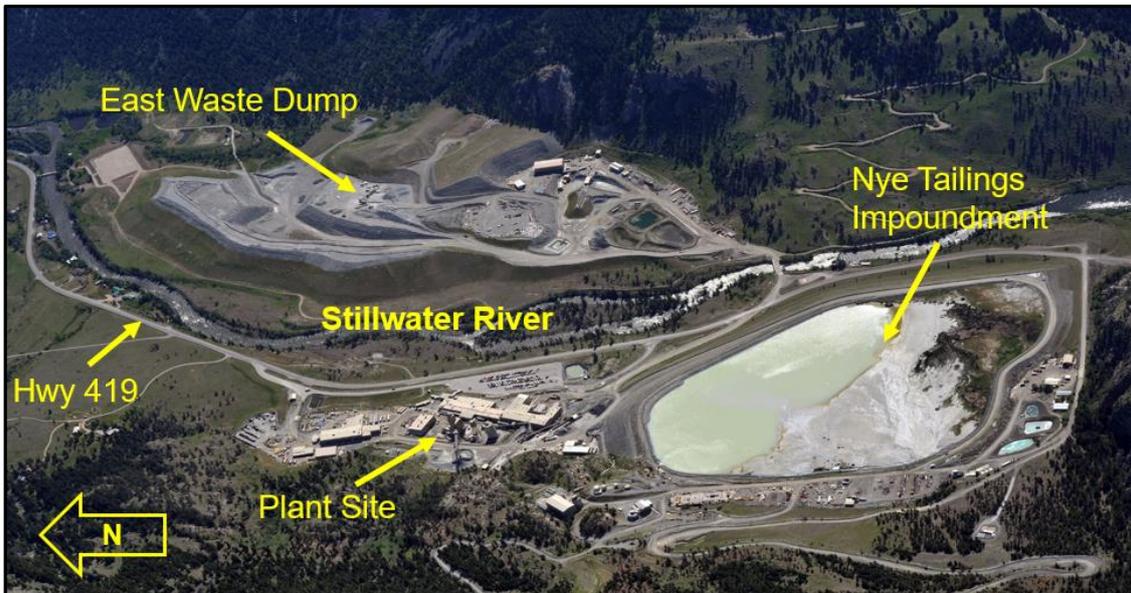
Figure 2 Nye Tailings Impoundment (looking East)

The Stillwater Mine is an underground platinum and palladium mine located approximately 5 miles southwest of Nye, Montana (MT) (Figure 1). The mine is owned and operated by Sibanye Stillwater. The mine comprises a 3,000 tpd concentrator, the Nye Tailings Impoundment, the Hertzler Tailings Impoundment, the East Waste Dump and other ancillary facilities to support the operation. The mine site layout, including the Nye Tailings Impoundment and the East Waste Dump, is illustrated on Figure 2.

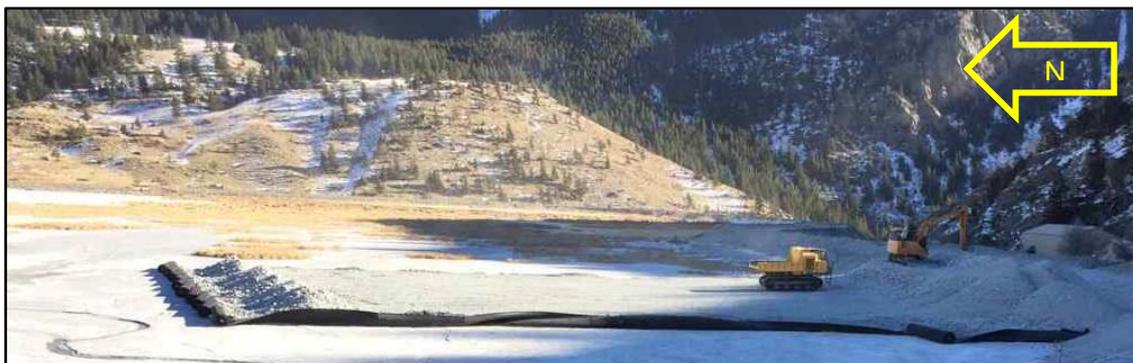
Construction of the initial 2 ft. (0.6 m) thick lift began in late 2018 and was focused on the exposed tailings surface along the south end of the impoundment as shown on Figure 5. A woven geotextile was placed over the tailings surface and a tracked crawler carrier with 360 degree rotation and excavator were used to place rockfill over the geotextile. This combination of geotextile reinforcement and low ground pressure hauling equipment has thus far yielded positive results with no significant trafficability or safety issues during construction.

Figure 5 Closure Cap – Initial Construction Progress

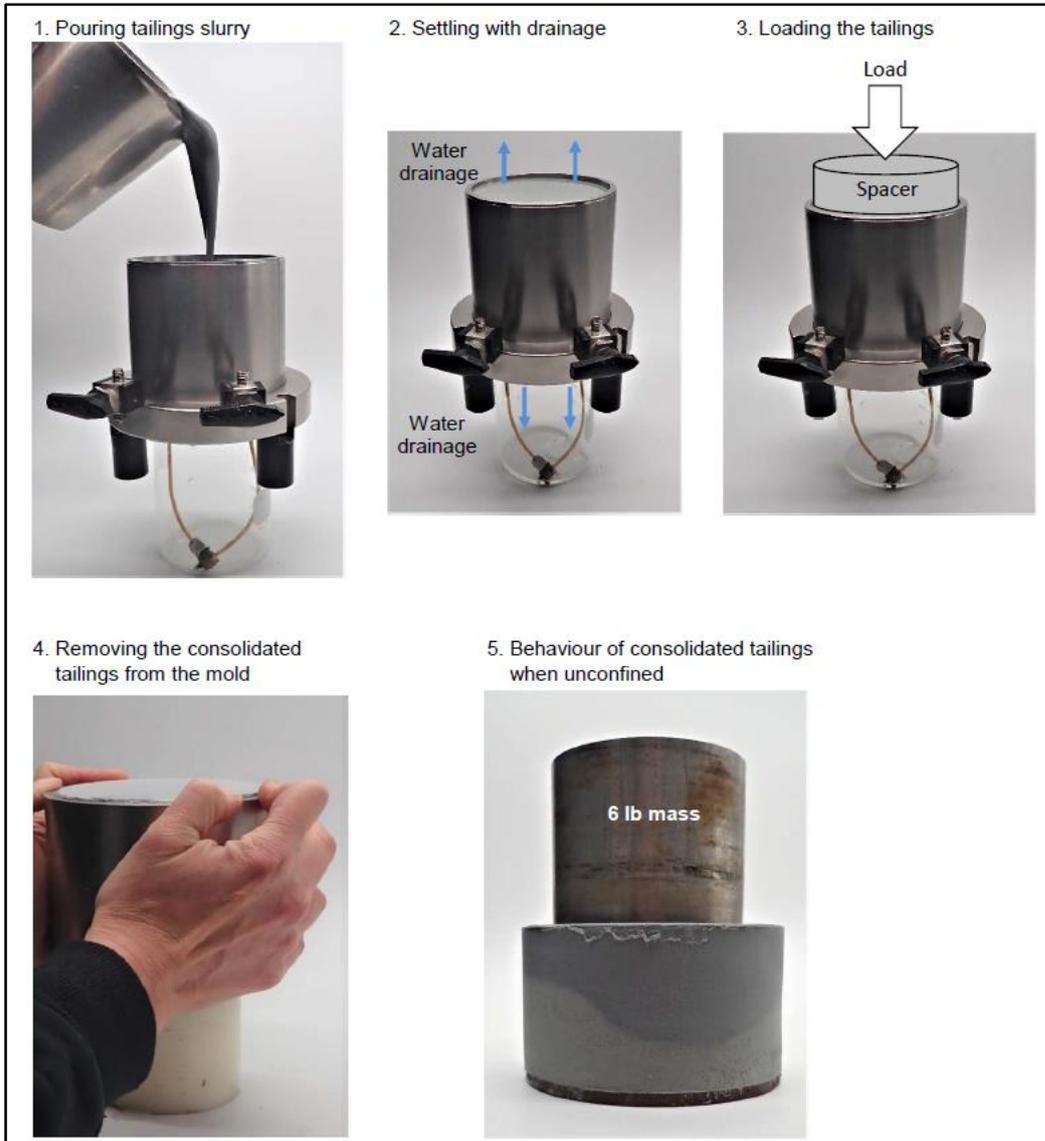
The ability for tailings to fluidize and flow decreases as the solids content increases and the moisture content decreases and the slurry transitions from a fluid state to a soil state. This behavior can be demonstrated using the slurry consolidometer laboratory test as illustrated on Figure 6.

Figure 6 Tailings Slurry Consolidation Test – Photo Summary

Slurry tailings are poured into the consolidometer mold and the tailings are allowed to settle under self-weight with drainage to the top and bottom of the mold. This simulates deposition and settling to reach equilibrium under self-weight loading for the near surface tailings. The tailings are then incrementally loaded with continued drainage to the top and bottom of the mold to simulate the additional settling that occurs at depth in an accreting column. Two-way drainage would apply to a TSF with underdrainage, but one-way drainage is more applicable for the Nye TSF. Once loading is complete, the consolidated tailings are extruded from the consolidometer mold and observed. This process simulates a reduction in confining stress similar to what would occur

during a dam failure event. The photos on Figure 6 illustrate tailings loaded to 150 kPa, equivalent to 23 ft. (7 m) of waste rock at the tailings surface.

The slurry consolidometer test demonstrates that consolidation loading is an effective means of densifying tailings to change the behavior from a fluid-like slurry to a soil-like solid under unconfined conditions.
