Challenges in ensuring stability whilst providing environmental compliance for existing TSF's

Abstract. The stringent requirements for tailings storage facilities (TSF) following the publishing of the Global Industry Standards for Tailings Management (GISTM) have required in depth stability supported by advance testing and modelling, where in the presence of a hazardous tailings facility would require knowledge of the barrier system. Often a buttress is required to increase the factor of safety from the one originally designed, complying with stability as well as environmental requirements, and most importantly without triggering any failure during construction. When the tailings and the buttress material classifies as waste, it adds one more level of complexity which needs to be accounted in the stability as well as in the barrier design system, especially when the materials requires different barriers system. The paper aim to present a project where the facility requires a buttress as the original design in the early 2000's was not acceptable in today's requirements. The stability pivot over a multi-layered barrier system (which does not allow Mohr-Coulomb failure criterion) and

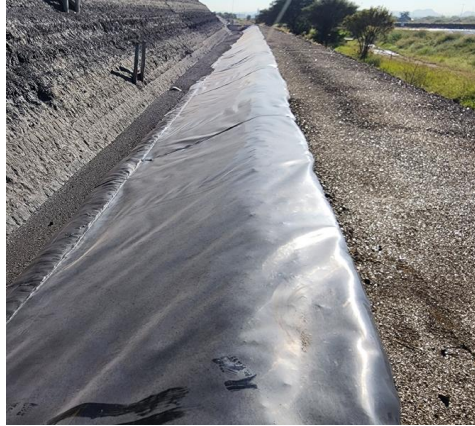
The presence of an existing toe wall as shown in figure 1 was considered as the boundary between the type 1 waste from the TSF and the type 3 waste from the buttress.

Fig. 1. Existing toe wall.

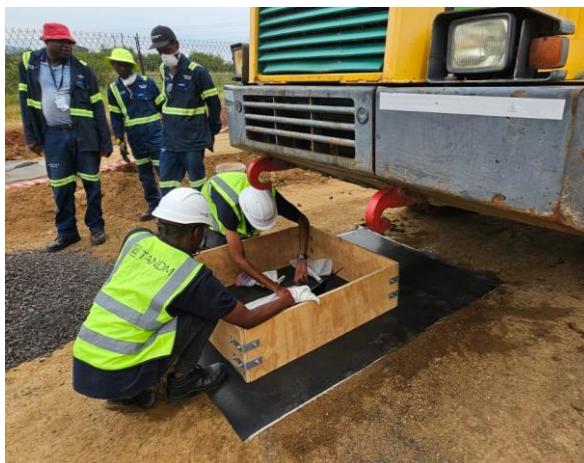
A protection geotextile has been specified to prevent damage by the buttress material ($D_{\max} 24\text{mm}$) with a unit weight of $1\,500 \text{ g/m}^2$ in polyester continuous filament. According to Hornsey [6], this compares to a $2\,200 \text{ g/m}^2$ polypropylene geotextile. Furthermore, a testpad has been constructed to check both damage to the liner as well as any strain in the geomembrane as illustrated in figure 4. Results from the testing confirmed that the maximum strain in the geomembrane with a load of 500kPa (full height of the buttress) results in a strain of 1.5% calculated using the Tognon et al. method [7] as illustrated in figure 5, which is below the value of 3% for which geomembrane would exhibit stress cracking potentials.

Fig. 4. Testpad under construction to monitor damage and strain in the geomembrane.

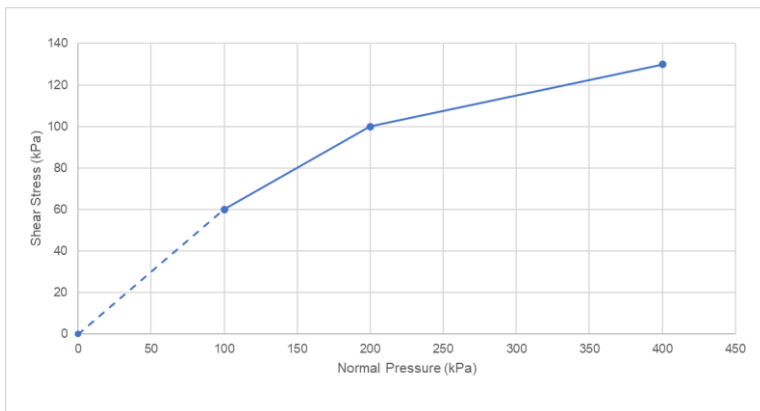
Testing in accordance with ASTM D5321 reported a ductile failure therefore the shear resistance at 10mm displacement was considered and the shear stress function in figure 6 was considered, with the cautious assumption of a 0 kPa adhesion.

Fig. 6. Shear interface function between GCL and residual soil.

The presence of a barrier system generally implies that the weakest failure plane is function of the weakest shear interface within the barrier system. As mentioned above, no testings were made available for the previous phases, therefore a literature value was used for the shear interface for the dormant dam and the active dam as different barrier systems were used. For the buttress, the dominant shear interface is between the residual soil and the GCL.
