Prepared by  
**Knight Piésold (Pty) Ltd**  
4 De La Rey Road  
Rivonia,  
Johannesburg  
South Africa,  
2128

Prepared for  
**Bakubung Minerals Proprietary Limited**  
Farm 259, R565, JQ Bultfontein  
Ledig  
Rustenburg  
North West Province  
RSA

Project Number  
**RI 301-00509/14**

## **BASELINE AQUATIC ECOLOGY ASSESSMENT FOR BAKUBUNG PLATINUM MINE**

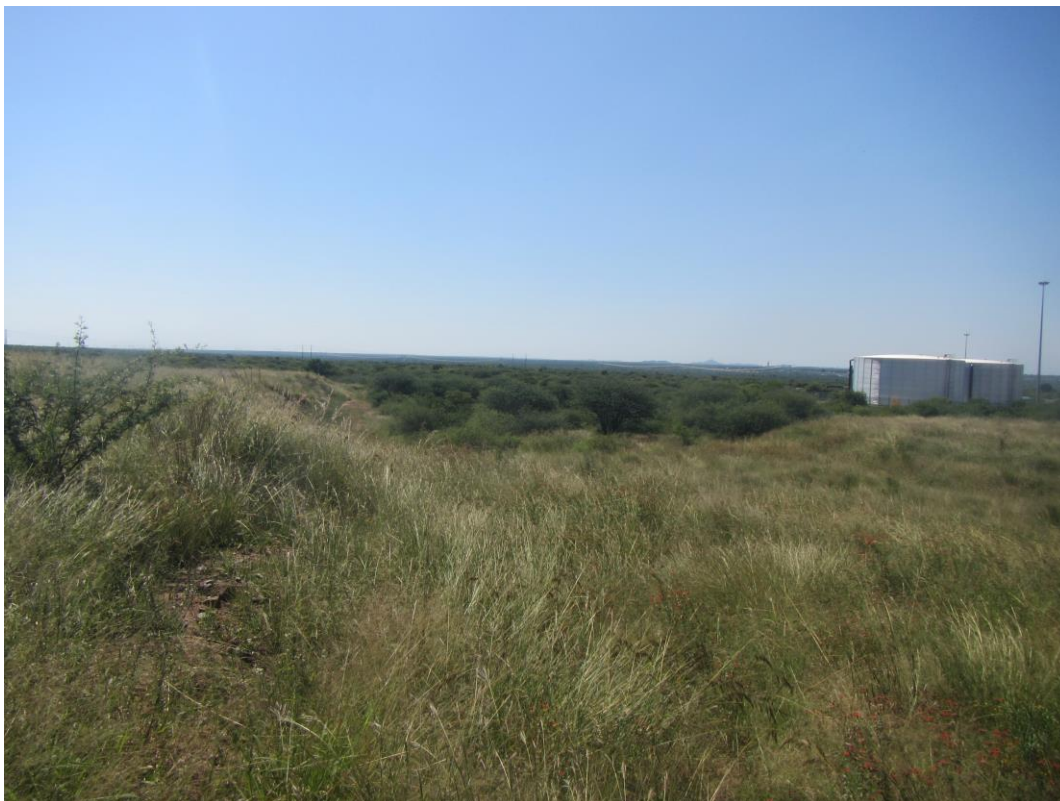
Wetland 8 (Figure 7) was classified as a unchanneled valley bottom wetland that drains into the ephemeral channel to the east of the project area. As stated in the previous baseline report, the wetland area has been separated in two due to mining activities, as a noise berm was constructed. The construction of the area for the water tanks and road to the staff accommodation has also altered the flow of water within the wetland. No culvert has been created for the water to flow under the road and has caused water to dam on the western section. The valley bottom wetland receives water from all the ephemeral channels that flow south and flows through the wetland.

**Plate 1: Unchanneled Valley Bottom Wetland looking towards the water tanks**

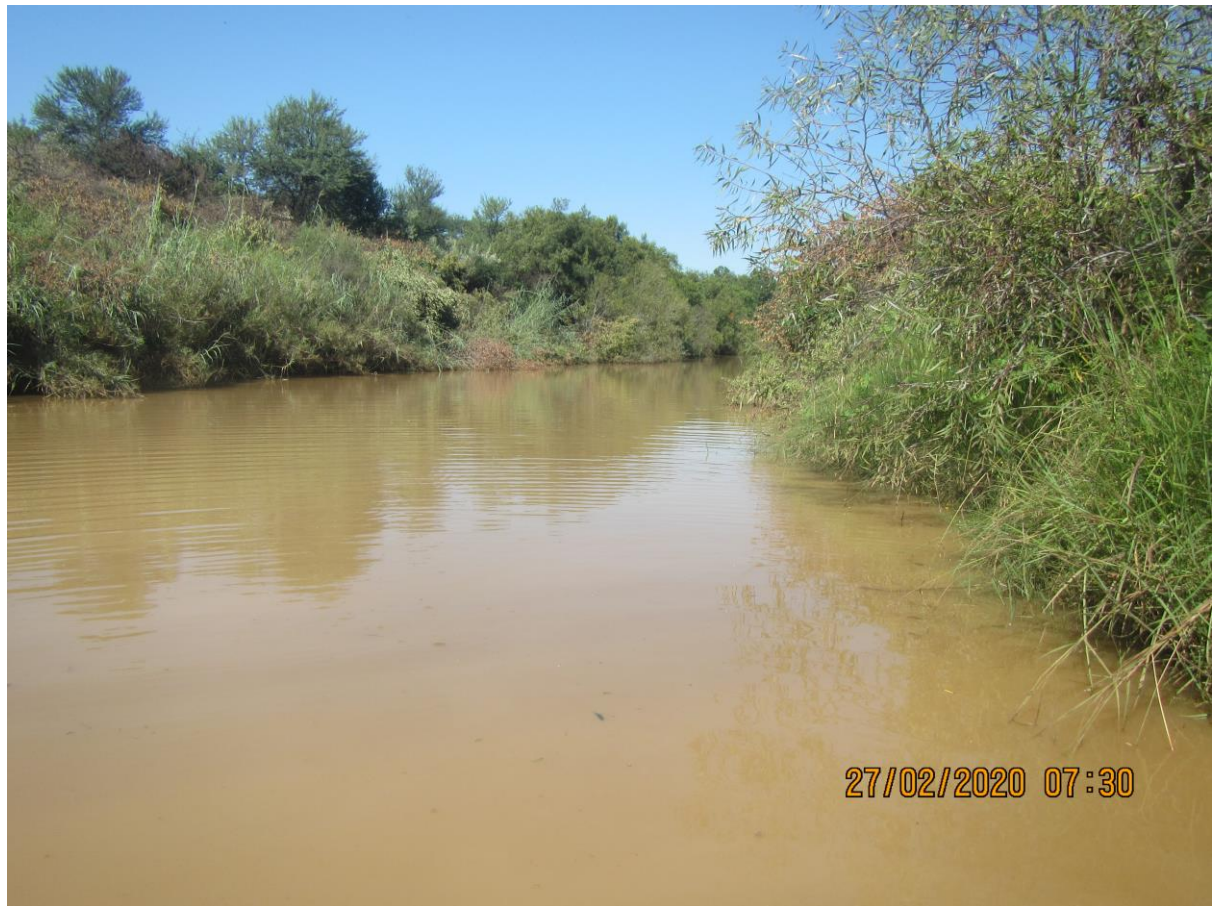
| Site Code | Description | Position UTM (WGS 84) |
|---|---|---|
| BKB-U | Located upstream of the Bakubung Platinum Mine. The site was accessed from the R565 which crosses the Elands river. The site is located underneath the bridge. The site provides suitable habitat for macro-invertebrates and fish species. | S 25.39255°<br>E 27.07106° |

**Plate 2: Bakubung Upstream Sampling Site**

The most dominant biotope upstream (BKB-U) was stones in and out of current, bedrock and boulders along with limited marginal vegetation and GSM, with no aquatic vegetation. The downstream point (BKB-D) was dominated by GSM, stones out of current and marginal vegetation. There was no aquatic vegetation or stones in current. Both sites had slow flowing runs and pools, with no significant riffles or rapids observed.

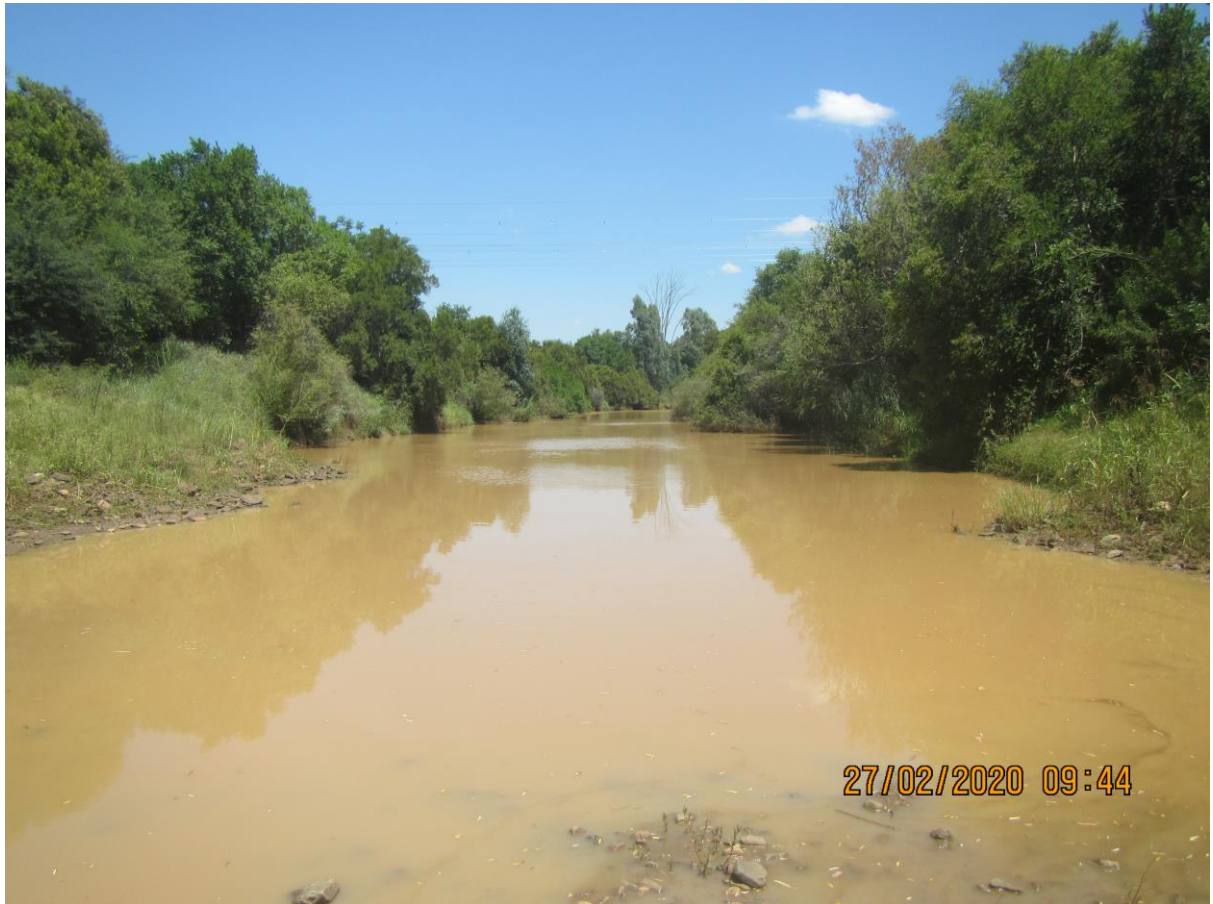
| Site Code | Description | Position UTM (WGS 84) |
|---|---|---|
| BKB-D | The downstream monitoring point is located directly downstream of the project area. The site was accessed from the dirt road that runs along the water pipeline. The site will provide baseline conditions downstream of the mining area. | S 25.39259°<br>E 27.09564° |

**Plate 3: Bakubung Downstream Monitoring Point**

BKB-D had an IHAS score of 44%, indicating that there was inadequate habitat available for macro-invertebrates within the aquatic ecosystem. The downstream site was dominated by sand and marginal vegetation out of current. It also had limited stones out of current, gravel and mud. The site had shallow and deep sections which were accessible for sampling.
